Post-Earthquake Reconnaissance of Unreinforced and Retrofitted Masonry Parapets

Marta Giarretton,^{a)} M.EERI, Dmytro Dizhur,^{b)} M.EERI, Francesca da Porto,^{a)} and Jason M. Ingham,^{b)} M.EERI

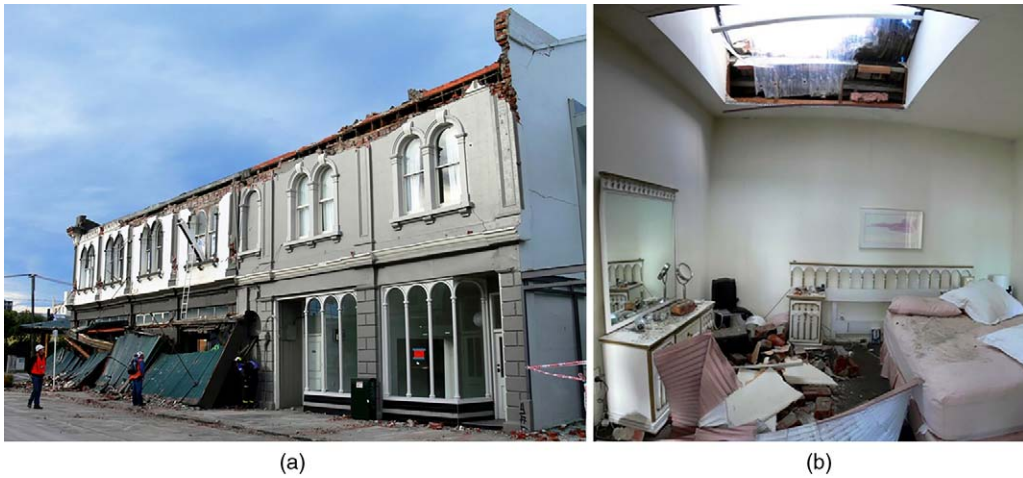
Figure 1. Examples of parapet failures during the 2010/2011 Canterbury earthquakes: (a) URM parapet that has collapsed onto the street frontage; (b) URM parapet that has collapsed into the building interior.

resulting in extensive out-of-plane failure during moderate-to-high intensities of earthquake shaking (Figure 1). Due to the elevated location and the extent of the parapets above the main street frontage and main building entrances, unrestrained parapets of URM buildings represent a major risk to nearby pedestrians and building occupants. Following the 2010/2011 Canterbury (New Zealand) earthquakes, it was reported that 70% (35 people) of the deaths caused by the collapse of URM facades or wall portions occurred outside the buildings, involving pedestrians, persons in vehicles, and people who ran out of a URM building to escape (Canterbury Earthquakes Royal Commission 2012, Johnston et al. 2014).

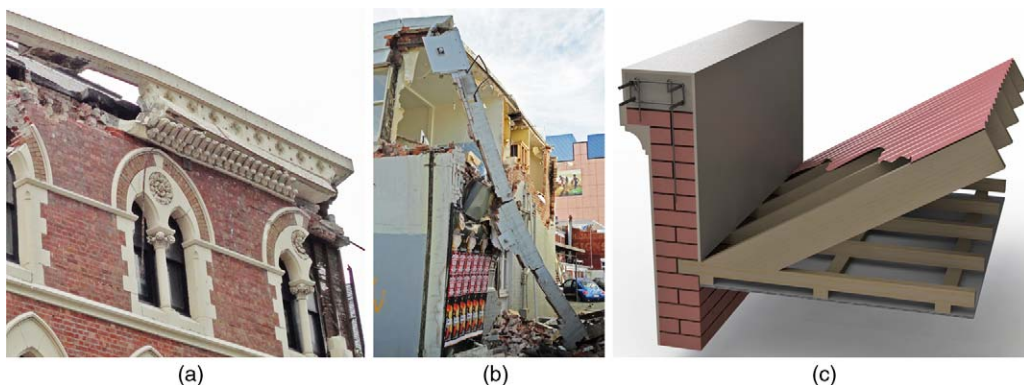
Figure 10. Examples of retrofit with the addition of a concrete bond beam at the top of the parapet: (a) typical concrete bond beam; (b) common failure; (c) design scheme.

Due to the increased mass the addition of a concrete beam at the top of the parapet was often the cause of collapse of the masonry parapet under the beam or the collapse of both the parapet and the concrete beam (Figure 21a). The typical failure modes of steel braces mounted behind the parapet were: (1) failure due to short embedment of the ties adopted to fix the beam to the parapet (Figure 21b); (2) horizontal cracking corresponding to the location of the horizontal steel beam, followed by collapse of the remaining un-retrofitted part above (Figure 21d); and (3) horizontal cracking at the base of the parapet. Collapse was typically observed when the parapet was retrofitted using only steel braces locally fixed with

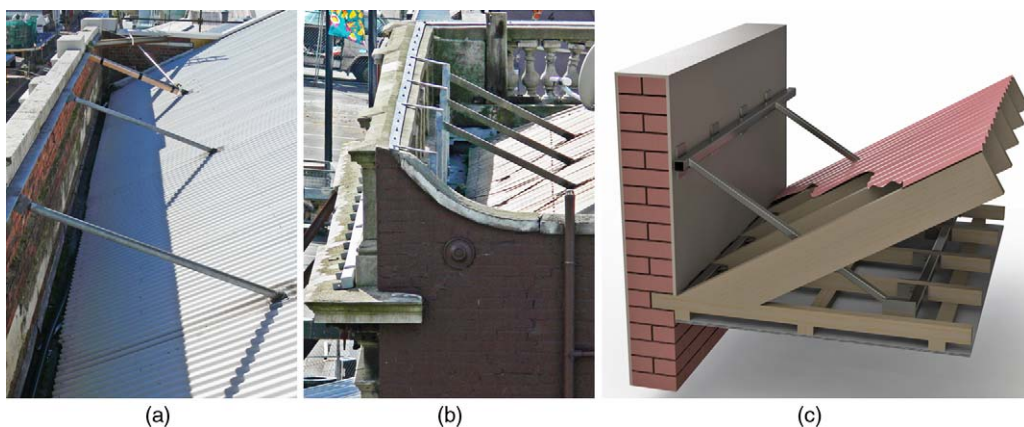
Figure 11. Examples of parapets braced back to structural elements: (a) typical braced parapet; (b) parapet braced back with top connection; (c) design scheme.

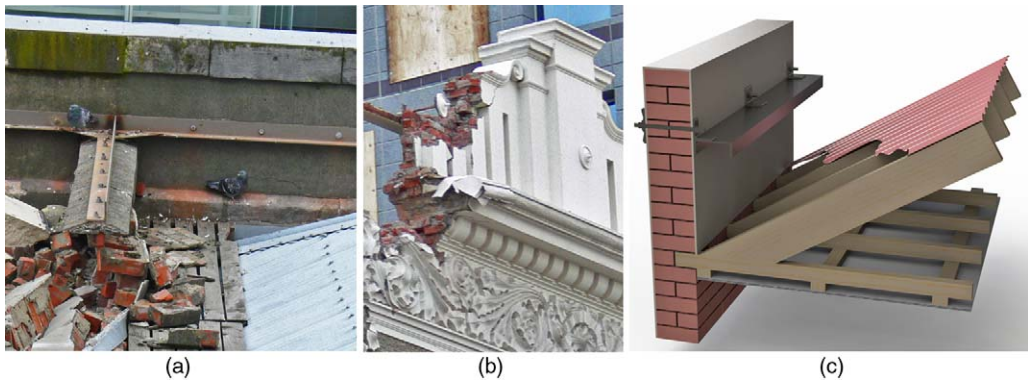
Figure 12. Examples of parapet retrofits utilising the addition of a steel strip on the back of the parapet connected with adhesive anchors: (a) rear view; (b) front view; (c) design scheme.

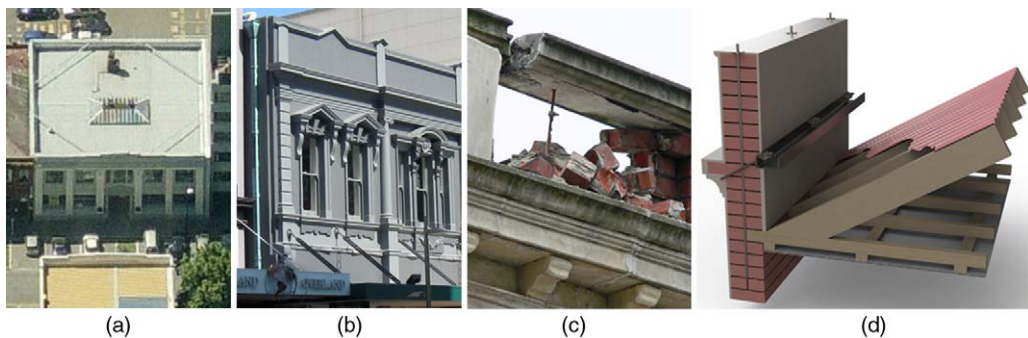
Figure 13. Other types of parapet interventions: (a) corner steel bar connection; (b) lightweight polystyrene replica; (c) insertion of vertical steel bars; (d) design scheme of the vertical bars.

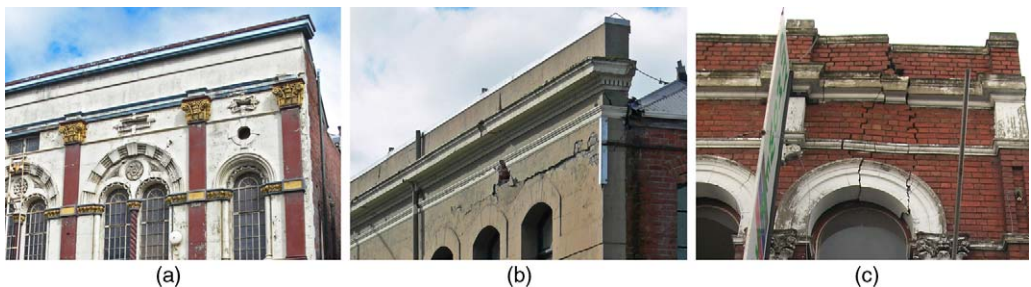
- Standing parapets, Figure 14, includes: (a) no visible damage, (b) visible horizontal cracking highlighting the initiation of rocking behavior of the parapet, and (c) other

visible cracking in the parapet related to in-plane failure of the full facade or pounding effect of nearby structures.

Figure 14. Examples of failure categories considered in standing parapets: (a) no damage; (b) horizontal cracking; (c) other types of cracking.

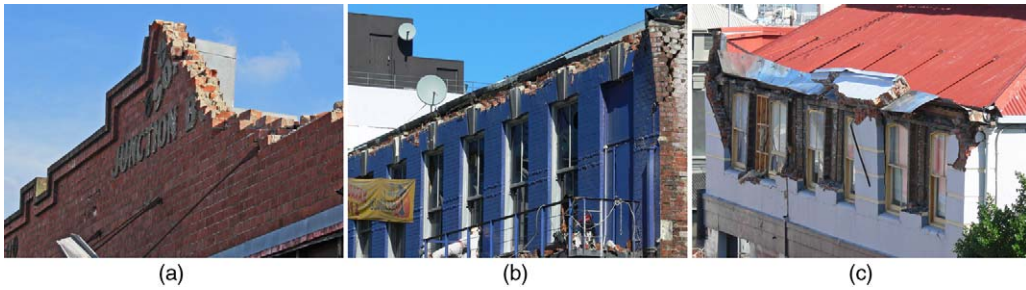
- Collapsed parapets, Figure 15, includes: (a) partial collapse of the parapet, (b) full collapse of the parapet only, or (c) collapse of the parapet and of the top part of the facade.

Figure 15. Examples of failure categories considered in collapsed parapets: (a) partial parapet collapse; (b) parapet collapse; (c) parapet and wall collapse (braced parapet).

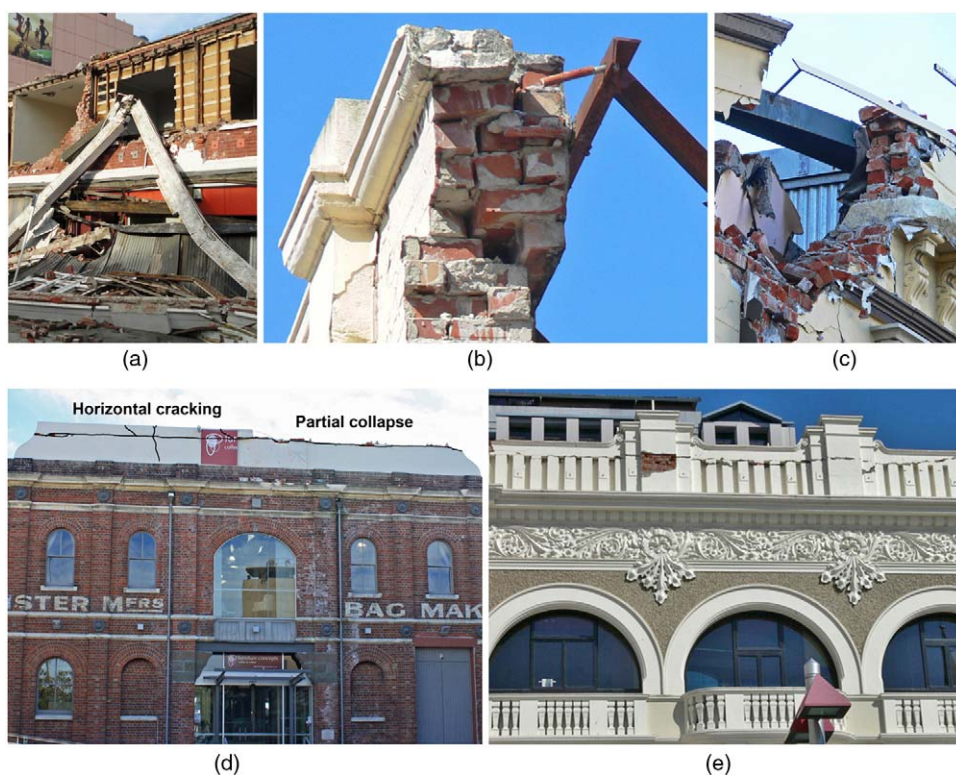
Figure 21. Typical examples of observed failure mode for adopted retrofit interventions: (a) collapsed concrete beam; (b) bracing back to structural element – short embedment of the adhesive anchors; (c) steel strip; (d) bracing back to structural element – cracking above the horizontal steel strip (highlighted in black); (e) steel strip – cracking above the horizontal steel strip.

location of the steel strip was observed when the steel strip was applied to all the perimeter parapets as a ring beam (Figure 21e). In some cases, it was recognized that the horizontal steel strip had occasional vertical steel struts connected to the roof structure, typically having insufficient capacity to support the parapet when subjected to earthquake loads.

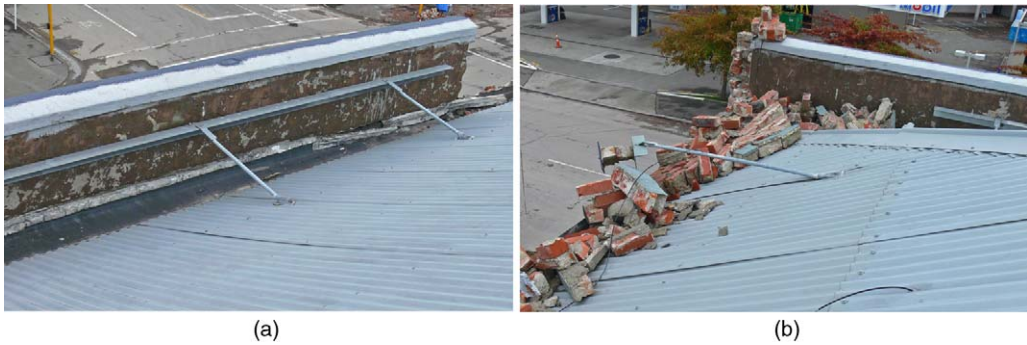
adhesive anchors or plates, without the presence of a horizontal steel beam, as shown in the building in Figure 22, where both systems were adopted. The use of horizontal steel strips fixed to the parapet with adhesive anchors resulted in the collapse of the parapet due to the absence of connection to a primary structural element (Figure 21c). Horizontal cracking at the

Figure 22. Performance comparison between parapets braced back to a structural element with and without a horizontal steel strip: (a) with a horizontal steel strip; (b) without a horizontal steel strip.
