### 3D VIRTUAL MODELLING OF A GOTHIC STAINED-GLASS PANEL

WG V/2 - Cultural Heritage Documentation

KEY WORDS: architecture, cultural heritage, laser scanning, 3D modelling.

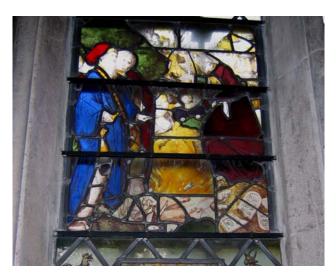
Figure 2. The lower and the higher register in the stained-glass window, exampling Bible scenes

A glass panel from southern chapel was chosen, mainly made of two parts: the lower, with a central part exampling the Nativity, and four animals around it [Figure 2].

The central panel is made of two parts, but probably it was a unique one which broke during its pose and was fixed with stain (see diagonal stain adjustment) and is inserted in the lower register of the window together with rhomboidal panels.

Central square panel is painted; it was probably coloured before or during its placement in the wall with the other glass sheets. Its colours are all very light, from white (painted all over the panel, as a uniform background), to gold (for some relevant details), to red to define contours.

The higher register has a different and more complex stain/glass structure: it is made of smaller and irregularly-shaped glass pieces [Figure 2]. It examples a Bible scene too, but instead of the former register it uses coloured (and not painted) glass, i.e. a glass which has been coloured during it production process through particular mineral compounds, such as blue for the dress of the character on the left or red glass for his hat. Thus, different details with different colours correspond to different pieces of glass fixed with stain. The same detail with one and only color, just like Bordeaux of the dress of the character on the right, is anyway divided into more pieces, and then fixed, but this can be both an aesthetic *escamoutage* and a solution to recover broken glass pieces of a sheet, perhaps.

In some parts, in this same register, additional colours were used subsequently to enhance contours or small particulars, such as the beards of the characters or the inscriptions on the boards (right inferior angle).

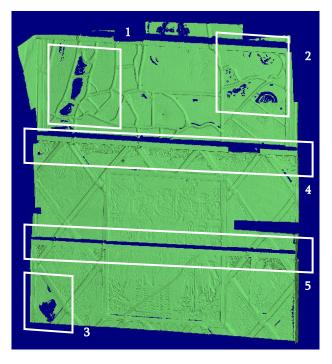
Figure 3. The global model of the stained-glass window with shading-mode visualization of the mesh and some relevant details (1 to 5)

The stripes were registered together [Figure 3] between couples and then merged all together to produce a single complete model of the stained glss window. The alignment errors are about  $0.15-0.2~\mathrm{mm}$ .

Scanned meshes have an average geometrical resolution of 0.2 mm x 0.2 mm circa, as it was expected. Let us to consider a single scan, for instance T2F1: it was acquired with Telescopic lens (T), at higher height (2), in the 6<sup>th</sup> stripe (F), the 1<sup>st</sup> from right (1); it has an acquisition area of about 175 mm x 130 mm, while points are about 300,000, as it was expected. In fact, the presence of a stain structure slightly protruding may have caused a brownout of glass and that is why there is a smaller amount of points. Moreover, it is normal to "miss" a very small part of back signal from the surface when it is so reflecting.

As it can be noticed in the final model, where a unique mesh has all aligned scans, acquisitions are homogeneous and have no apparent deformations. This is an important result for this work: glass is a very special material, because of its high superficial reflectance and its complex micro-morphology

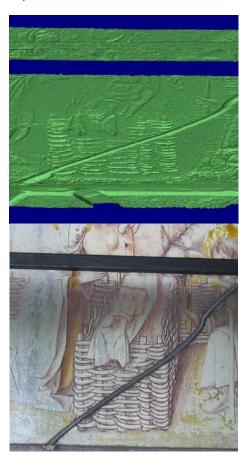
Figure 7. Comparison between virtual mesh and photograph of the painted detail of the basket in the middle of central panel

Acquisition of a stained-glass window with a sub-millimetrical sensitive instrument can provide interesting information on local micro relief of its decorative details [Figure 7]. In fact, particularly with painted sheets, it is possible to have a micromapping of the surface with indications on the thickness of each coloured layer.
