The Tessina landslide

Alessandro Pasuto, CNR-IRPI Padova alessandro.pasuto@irpi.cnr.it

Fabio Gabrieli, dept ICEA, University of Padova, fabio.gabrieli@unipd.it

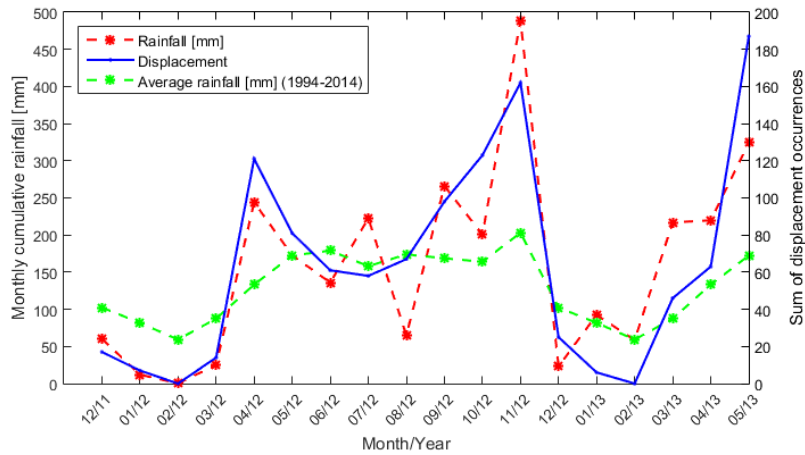
Fig. 2: Monthly cumulative rainfalls and displacement occurrences captured from automatic photographic monitoring.

The second predisposing and triggering factor is related to the pluviometry of the area: according to the recent data based on 20 years of hourly measurements (1994-2014; San Martino weather station) here we have a mean annual precipitation of 1683.3 mm and an average of 121 rainy days a year and a slight bimodal seasonality with peaks in November (203.1 mm) and Spring. This is one of the most wet area of the Veneto region together with Cansiglio (20 km far), Cismon and Recoaro areas.

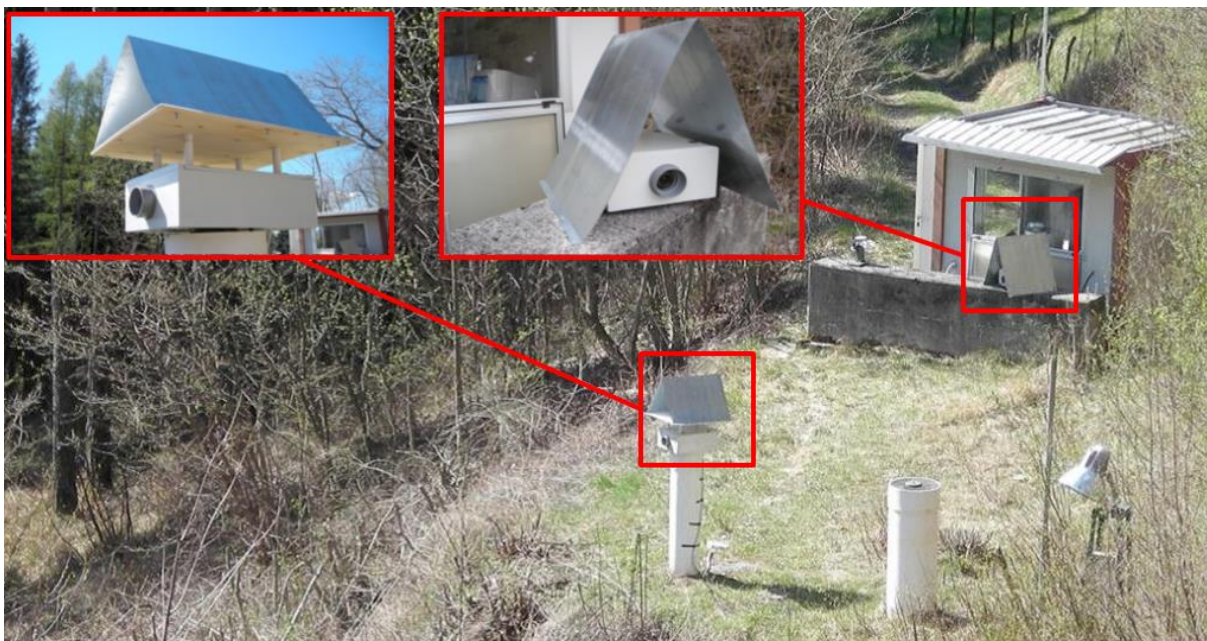
Fig. 4. The monitoring station at Moda when it was equipped with a stereo-photogrammetric setup (Antonello et al, 2013).

Hiking on the west side of the valley, along via Moda, we can reach the monitoring station. From here we can observe the north-eastern crown of the landslide body.
