HERITAGE 2022 INTERNATIONAL CONFERENCE VERNACULAR HERITAGE: CULTURE, PEOPLE AND SUSTAINABILITY

An architectural catalogue for the study of traditional building features from their seismic behaviour in the 2016 Central Italy earthquake

Luca Sbrogiò¹, Ylenia Saretta², Maria Rosa Valluzzi³

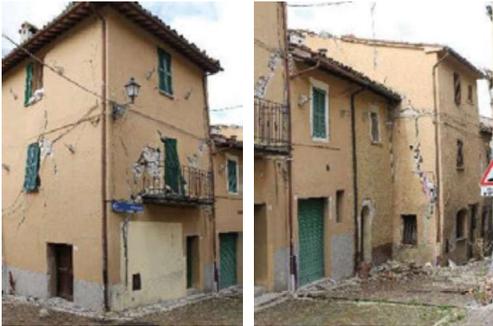
The position of a building within a block determines the mutual buttressing effect: corner and end units showed higher damage than internal

ones as they lack of it (Fig. 1, left). The façades of clogging units, i.e., those built between already existing buildings, were often not properly connected to the adjacent ones. Misaligned cells in plan are exposed to corner overturning as well (Fig. 1, right). These situations, strictly connected to construction processes, favored the first mode mechanisms (overturning of walls and corners) (Fig. 2).

Fig. 1. Terrace in Castelsantangelo sul Nera: damage on head unit (left), overturning of façade in jutting unit (right)

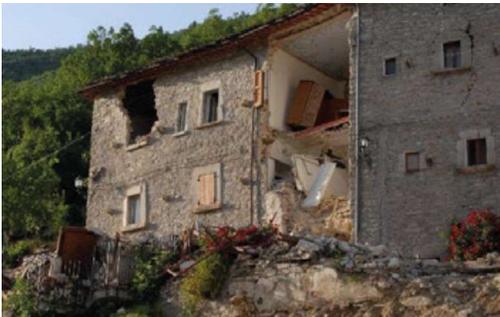
Fig. 2. Overturning of façade in a clogging unit (Nocria)

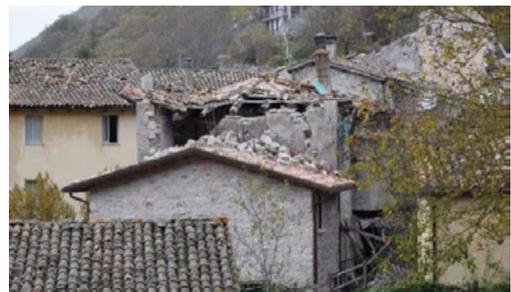
As regard the elevation, some units stand higher than the eave line of the surrounding ones and, therefore, have free walls on one or both sides. As these latter were generally unrestrained by tie rods, they suffered of out-of-plane mechanisms, causing damage also to the roof of the adjacent units (Fig. 3). A unit higher on both sides than the neighboring ones was the most unfavourable situation.

Fig. 3. Overturning of standing walls (Castelsantangelo sul Nera)

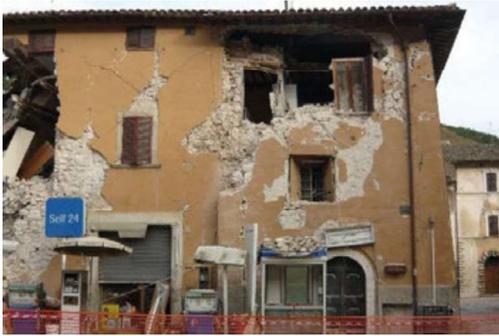
In the study area these factors were often combined, resulting in severe damage patterns (Fig.

4). Conversely, provided that masonry quality is good, a well-arranged façade system, i.e., squat piers and an even distribution of openings ensured an overall behaviour with minor damage.

Fig. 4. Crumbling of masonry and shear damage owing to misaligned openings (Visso, courtesy of Eng. Falsetti)

Façades are made of undressed or roughly cut stones, randomly laid in poor mortar (lime and/or clay); their cross-section is divided in two or three leaves, without bonding stones. Overall, the poor masonry quality (Borri et al., 2020) eased both the crumbling of walls, owing to the lack of connections in the cross-section, and first-mode mechanisms, owing to poor interlocking between walls. Crumbling took place before any damage mechanism could activate, and it interested the outward layer of a wall, especially when r.c. roofs and tie beams were added to the building. Damage associated to crumbling is severe and often determines the loss of a building (Fig. 4).

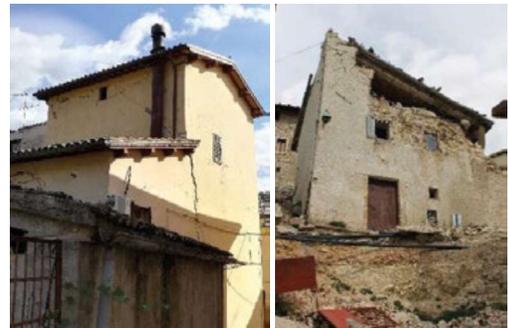
ii) ‘Standardized’ interventions, which were applied starting from the 1970s, in compliance with seismic codes and handbooks, prescribing rigid floors (Sbrogiò et al., 2022). Standardized r.c. elements replaced existing floor joists and roof beams, and r.c. tie beams were added to connect the walls at floor and roof levels. These interventions, which added mass and stiffness to the horizontal structures, were not compulsorily associated with the strengthening of the bearing walls, which crumbled, resulting in severe damage (Fig. 5 right). The available strengthening solution for masonry walls was a cement plaster reinforced with a steel mesh.

Fig. 5. Left: pounding owing to staggered roofs (Pieve Torina); right: masonry crumbling and r.c. roof collapse (Campi Alto)

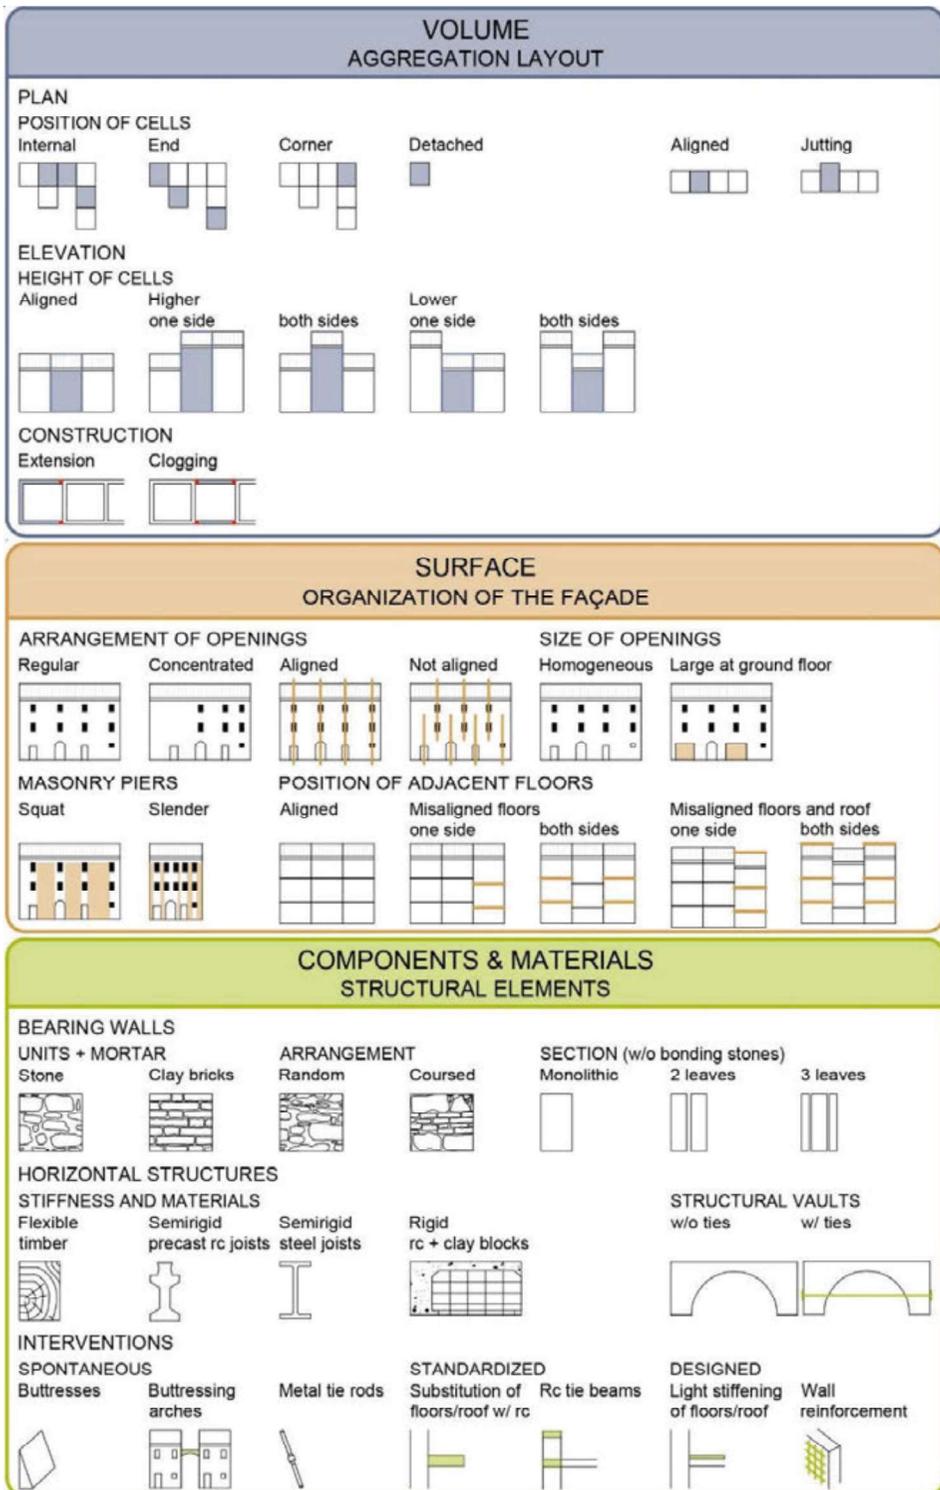
Fig. 6. Proposal of a catalogue of architectural hallmarks in a historical center

Fig. 6 shows the resulting catalogue for the ordinary masonry buildings in the study area, grouped as described in § 4.

The observations highlighted that damage patterns resulted from the interaction of multiple factors. The overall structural response of a building was mainly due to its components and materials, i.e., to the masonry quality. Secondly, it was governed by the surfaces, i.e., the layout of façades as a function of the distribution of stiffness and masses, which determined the damage distribution. Finally, the irregularity of the built volume determined localized damage with cracks at the interfaces between buildings and damages due to the fall of debris from adjacent units.

Proper interventions (type ii or iii) on masonry walls obtained minimum damage to buildings, even in the epicentral area (Sisti et al., 2022). However, the strengthening of walls determined a relevant alteration of the original features of a building.
