Article

Dynamic-Based Limit Analysis for Seismic Assessment of Free-Standing Walls of San Giovanni Church in Castelseprio UNESCO World Heritage Site

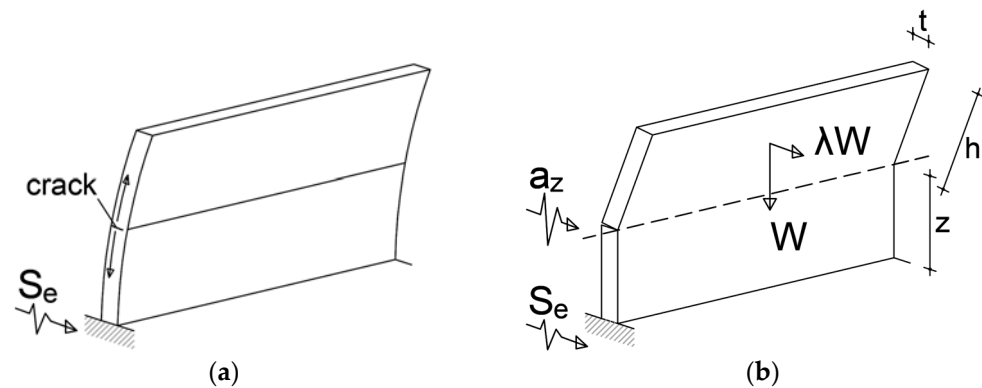
Figure 2. Structural scheme for the computation of local mechanisms: (a) tensile stresses arising in the material due to the vibrations proportional to mode shapes and crack formation; (b) equivalent macroblock and local mechanism: the dashed line represents the position of the plastic hinge on the compressed side. S_e and a_z are response spectra at the ground and hinge level, respectively.

The analysis returns the elastic stresses in the material but, due to the small tensile strength of masonry f_t , where the principal tensile stresses exceed this value on the tensioned side of a wall, cracks are expected, with the consequent formation of plastic hinges on the compressed side [21] (Figure 2).

The macroblocks involved in the local mechanisms are those parts of the walls above the cracks, where displacements are the largest (Figure 2a). The first position of a wall where the tensile strength is exceeded corresponds to the opening of the cracks, leading to the formation of plastic hinges: the portion above the hinge (where the tensile strength is always exceeded) is the macroblock affected by kinematics, whereas the portion below is considered stable since there is no redistribution of forces (Figure 2b).

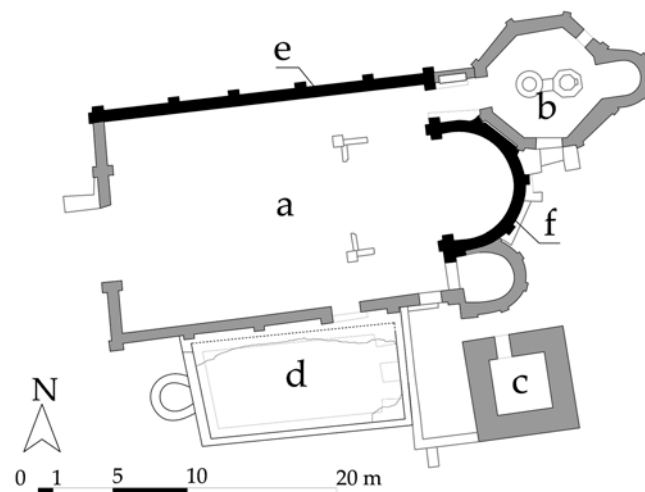
Figure 3. Plan of the S. Giovanni complex. The letters mark: (a) church; (b) baptistery; (c) bell tower; (d) cistern; (e) north wall; (f) main apse (adapted from [79]). The walls studied in this paper are marked in black.

The church of San Giovanni is part of a Christian complex that includes a basilica, a monumental baptistery, a tower, and a cistern (Figure 3).

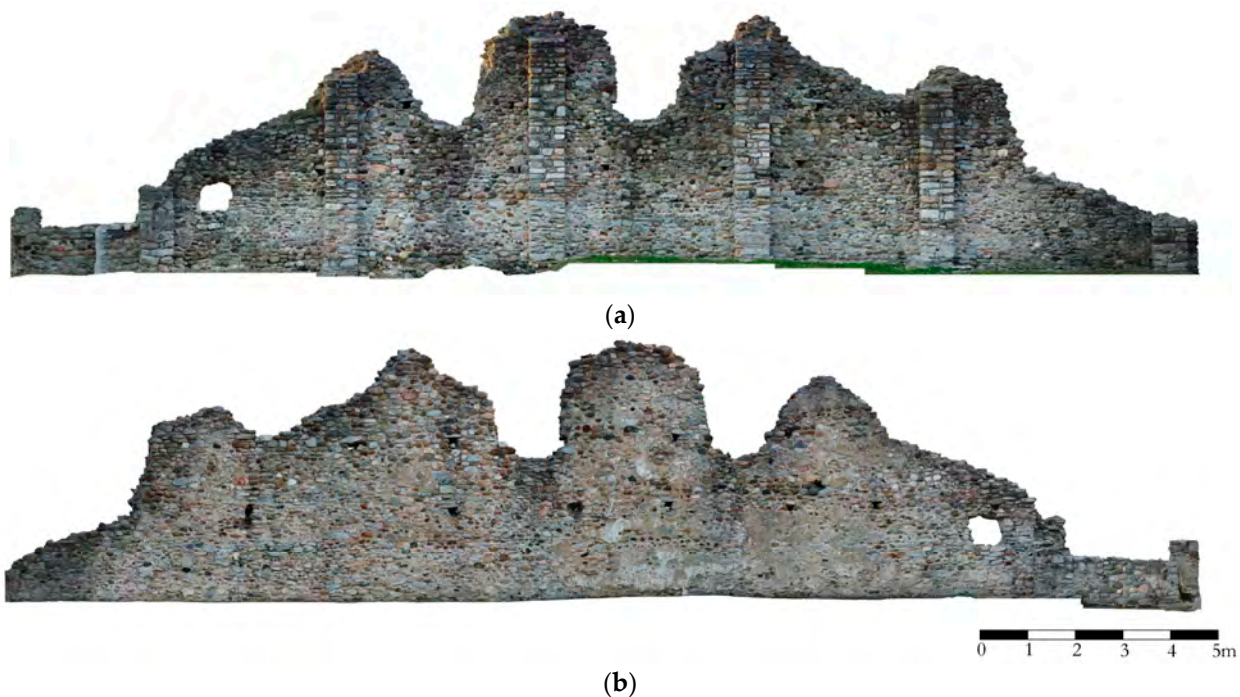
Figure 4. Church of S. Giovanni; elevations of the north wall: (a) external; (b) internal (credits: P. Vedovetto, adapted from [79]).

Currently, the state of preservation of the surviving walls varies significantly. The facade has almost entirely disappeared, leaving behind scant remnants. The side walls stand preserved up to approximately 5 m in height, while the apse section remains relatively

intact, reaching a height of nearly 10 m (Figures 4 and 5). In contrast, the walls of the baptistery have a uniform height just above 1 m, suggesting intentional demolition [75].

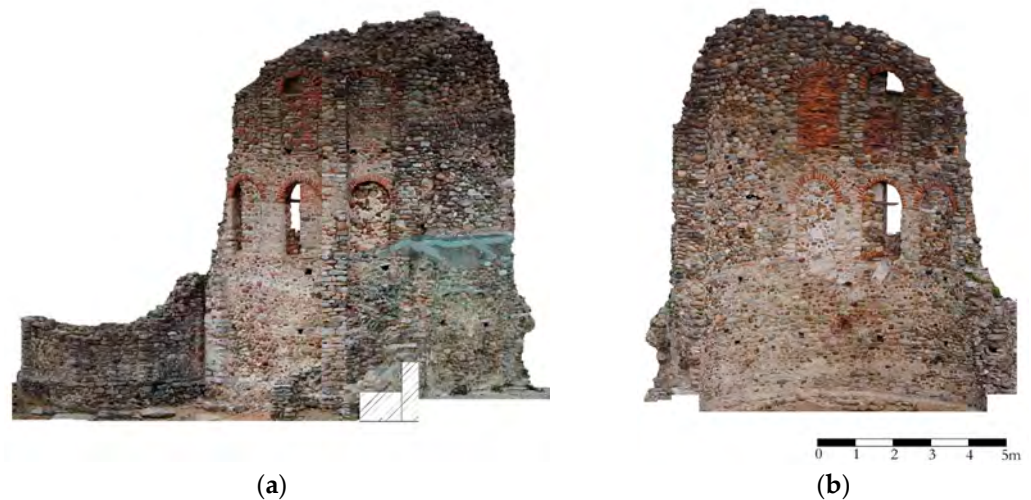
Figure 5. Church of S. Giovanni; elevation of the main apse: (a) external; (b) internal (credits: P. Vedovetto, adapted from [79]).

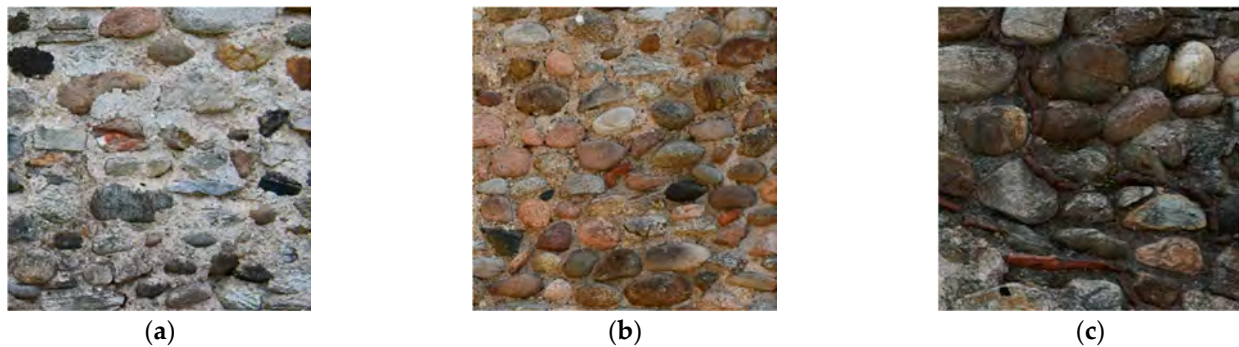
Figure 8. Mortar types in S. Giovanni: (a) lime and clay; (b) lime and crushed pottery; (c) cement.

On-site visual analysis confirmed the recognition of at least three types of mortars (Figure 8): one light grey, used in the perimeter walls, with a clay component [81]; one brownish, probably due to the presence of crushed pottery [80]; and one in dark grey, of cementitious nature and used in modern restorations. All these mortars appeared to be very compact and adherent to the stones, and no signs of disaggregation were detected. The brownish mortar was found in the apse wall, whereas the other two types in the north wall.

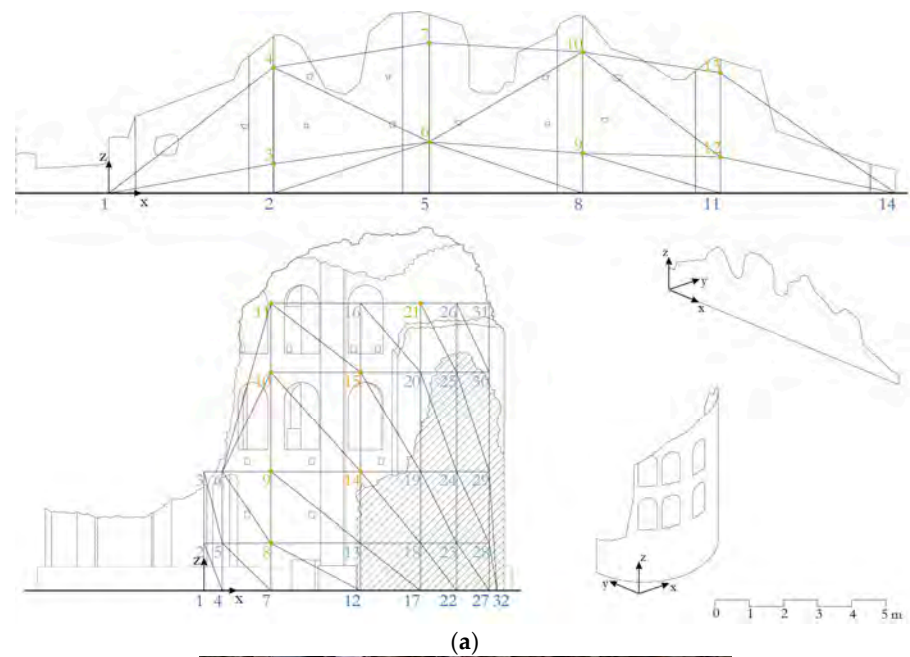
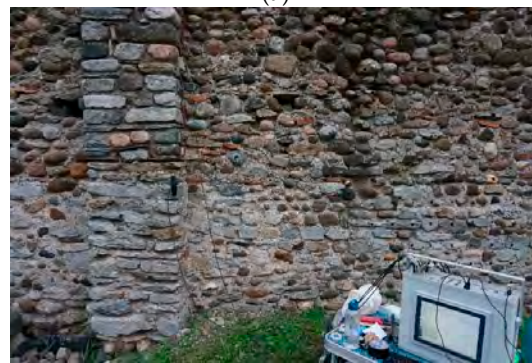
Figure 10. Setup of dynamic identification tests: (a) elevation of the grid for sensor positioning on the north wall and the apse; (b) view of accelerometers and acquisition system.

Eight piezometric accelerometers were placed according to a triangular grid pattern on the external face of the north wall, while seven accelerometers were installed on the southern half of the central apse due to limitations imposed by the adjacent baptistery wall and its shelter roof (Figure 10a). The sensors were temporarily affixed with hot glue, for avoiding drilling into the archaeological material, and were cable-connected to an acquisition system, recording signals at 10 min intervals over an hour (Figure 10b). They were applied on the external side of both structures, as the interior of the church is occupied by the archaeological excavations.

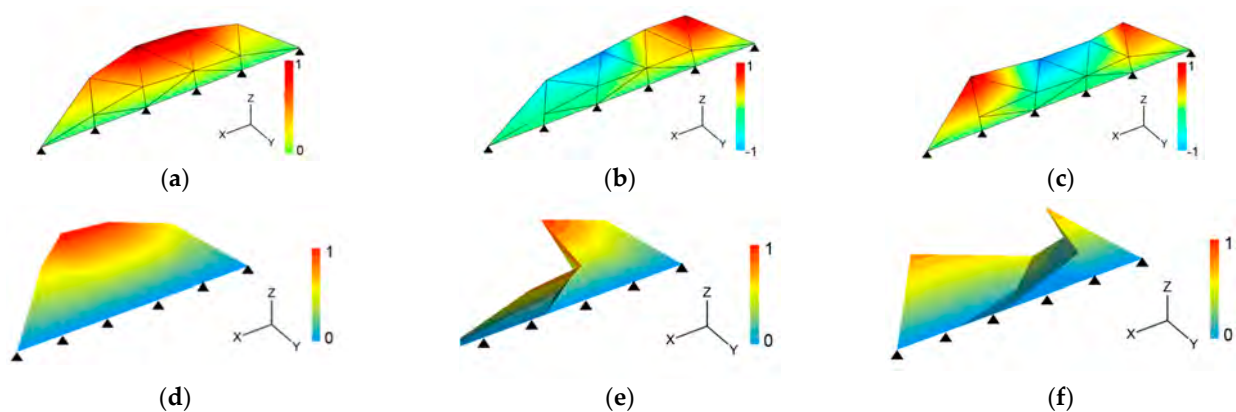
Figure 11. North wall, experimental mode shapes: (a,d) first mode; (b,e) second mode; (c,f) third mode; (a–c) processing in MACEC; (d–f) processing in ARTeMIS. The black triangles represent the fixed nodes at the base; the displacements are normalized to the maximum and minimum values.

The results of the two approaches are compared through the calculation of the MAC index (Table 5): as the indices on the diagonal of the matrix are larger than 0.9, a good consistency between the results is obtained, and thus, the calculated modes can be assumed with reasonable confidence.

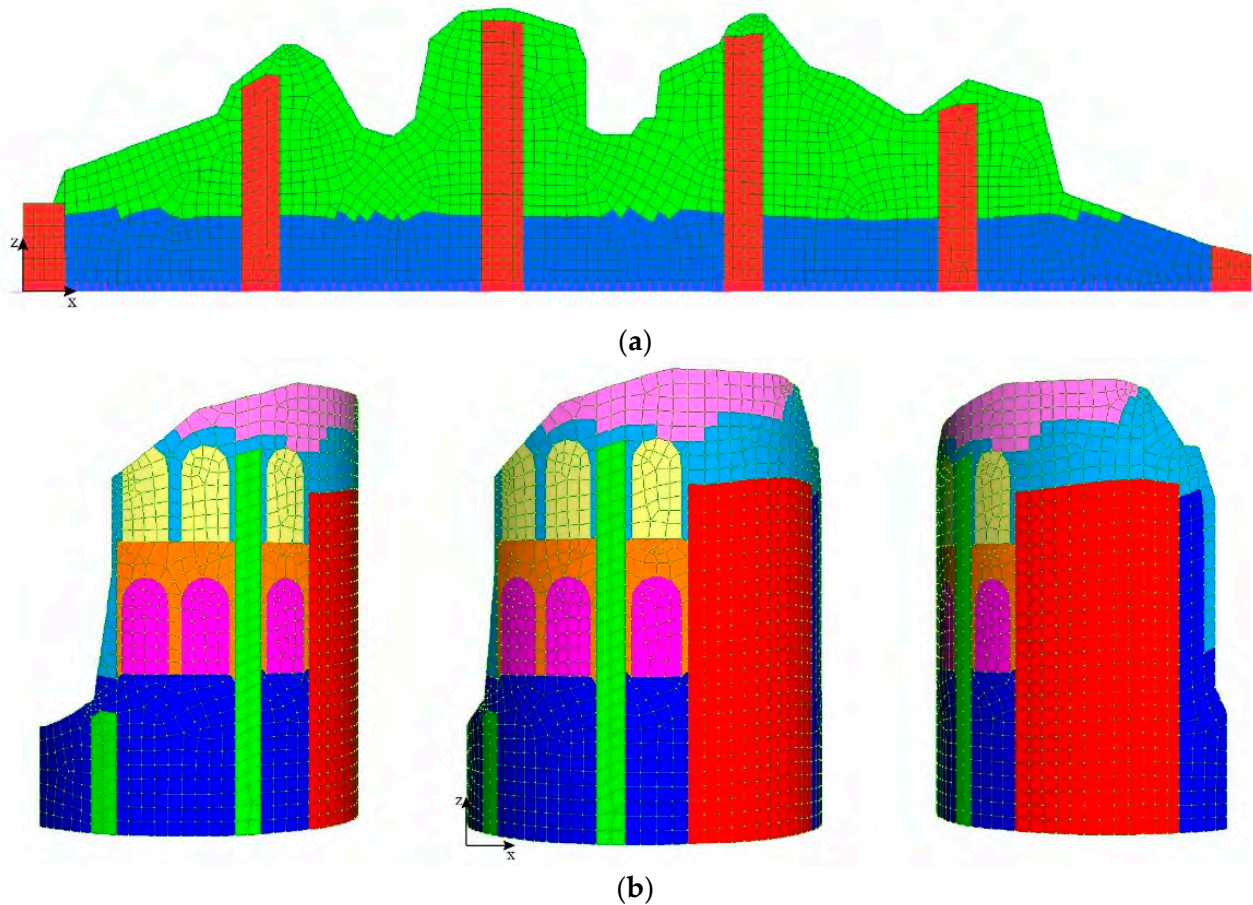
Figure 13. FE models of (a) north wall and (b) main apse. Key to colors in Tables 9 and 10, respectively.

type by [6] was the same as the north wall, the density was reduced to account for the lower sonic velocities. Figure 13b shows the FE model of the apse that considers all the local variations in masonry properties.

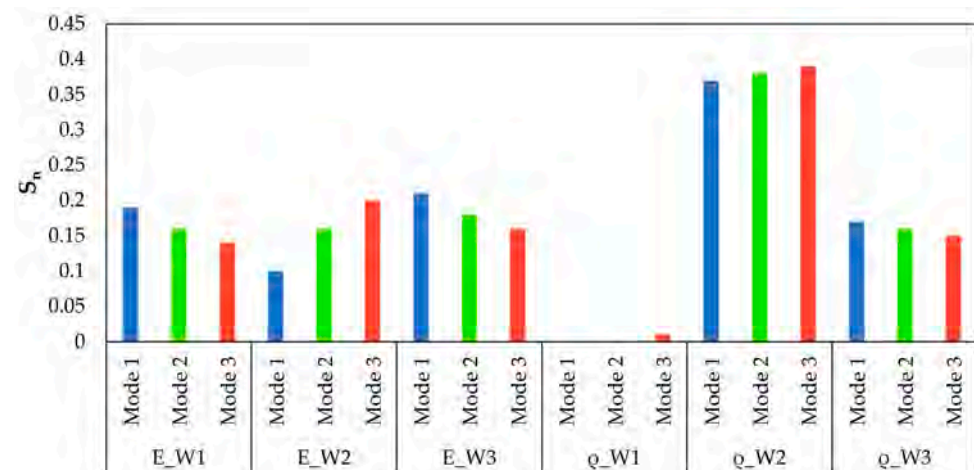
**Figure 14.** Sensitivity indices (S_n) from the variation of elastic modulus E and density ρ in the north wall.**Table 12.** Final mechanical properties of the north wall (after calibration).

As depicted in Figure 14, the most influential parameter (S_n about 0.40) on the three modes was ρ_{W2} , i.e., the density associated with the upper portion of the wall (W2). Conversely, variations in the density of the lower portion of the wall appeared to be irrelevant for the model (W1). The elastic moduli of the three considered properties (W1–W3) and the density of the buttresses (W3) had a similar impact on the FE model, with S_n values ranging between 0.10 and 0.21. Table 12 presents the final mechanical properties of homogeneous masonry areas for the north wall.

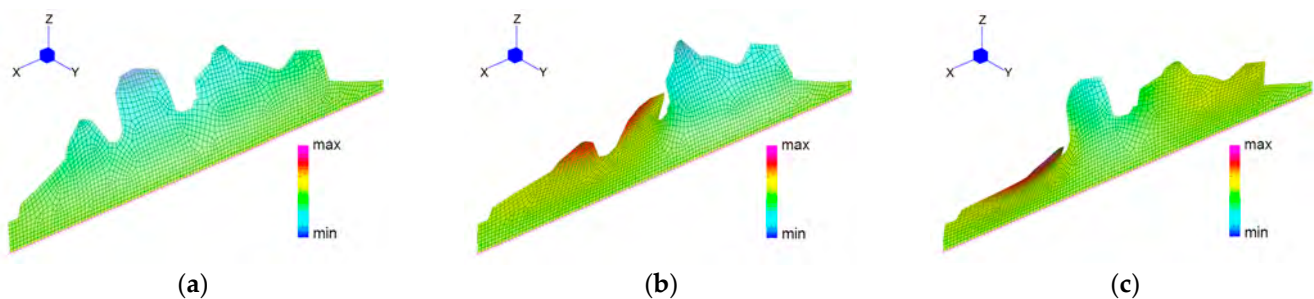
Figure 15. North wall, updated FE model mode shapes: (a) first-order bending; (b) torsional; (c) second-order bending.

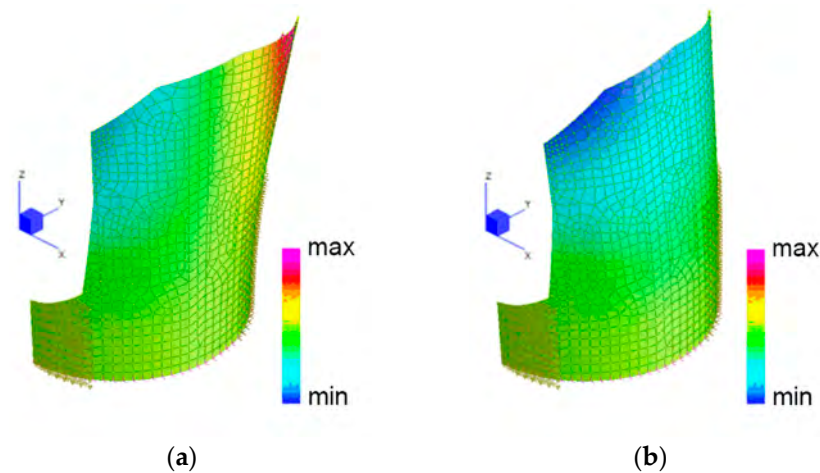
Figure 16. Apse, updated FE model mode shapes: (a) torsional; (b) bending.

The final frequencies obtained in the calibrated model of the apse are 4.08 Hz for the first mode of vibration (torsional) and 4.42 Hz for the second mode (flexural) (Figure 16), with MAC indices exceeding 0.9 for both the first two diagonal terms of the FEM-pLSCF matrix and those of the FEM-EFDD matrix (Table 14). The errors between the final frequencies obtained and the corresponding experimental analysis frequencies are negligible.

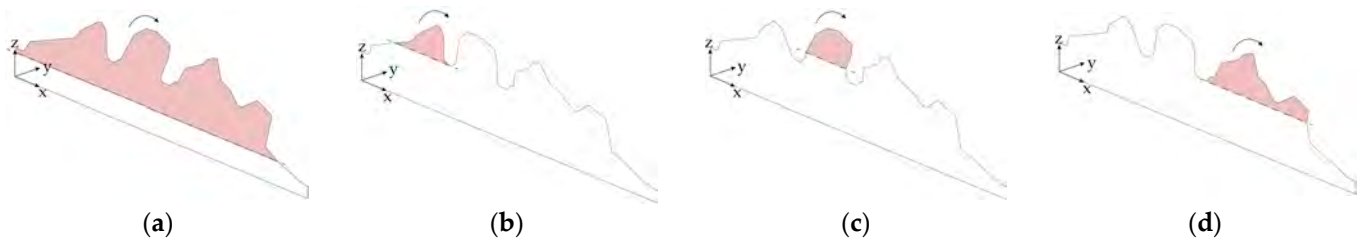
Figure 19. North wall, macroblocks, and local mechanisms of collapse (compare Figure 17): (a) DL limit state; (b–d) NC limit state.

The macroblocks that were defined according to the positions of the hinges at the two limit states and the local mechanisms that could affect them are displayed in Figures 19 and 20 for the north wall and the apse, respectively.

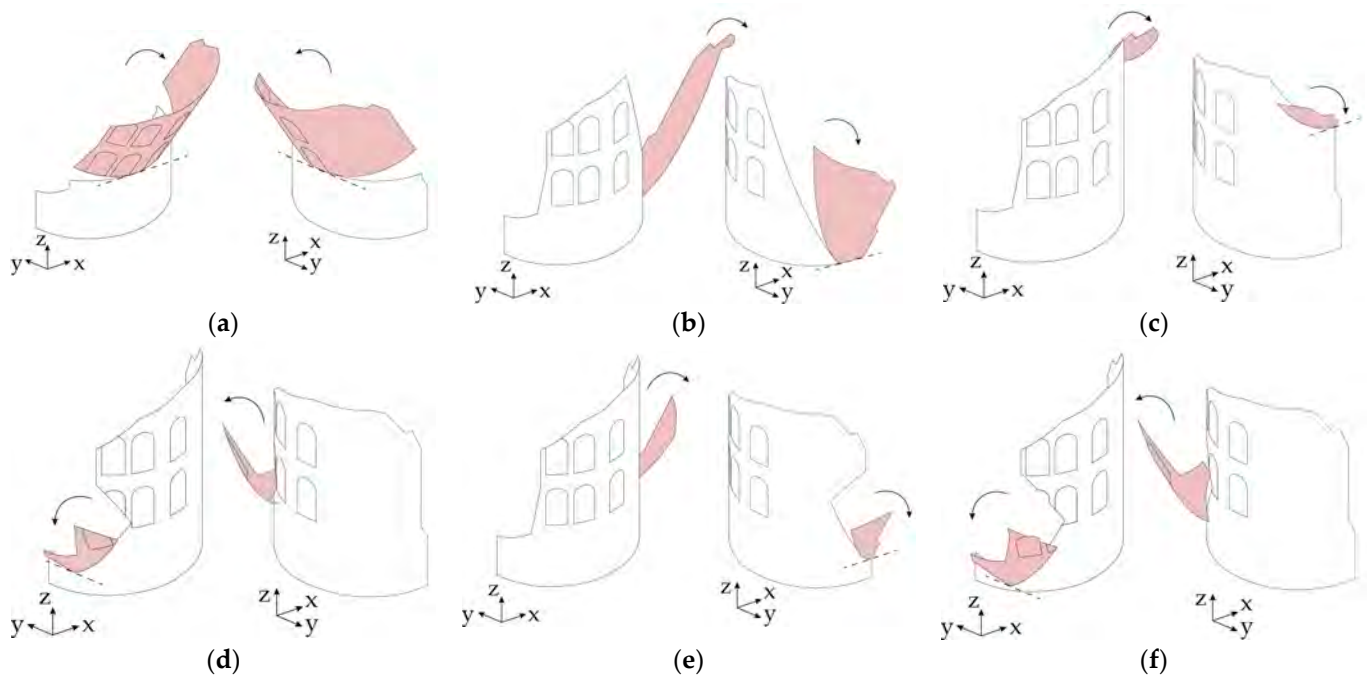
Figure 20. Apse, macroblocks, and local mechanisms of collapse (compare Figure 18): (a,b) DL limit state; (c–f) NC limit state.
