# EXISTING BRIDGES: RISK OF FAILURE IN THE CLIMATE CHANGE CONTEXT

Pietro Giaretta & Paolo Salandin Dept. of Civil, Architectural and Environmental Engineering, University of Padova pietro.giaretta.1@phd.unipd.it

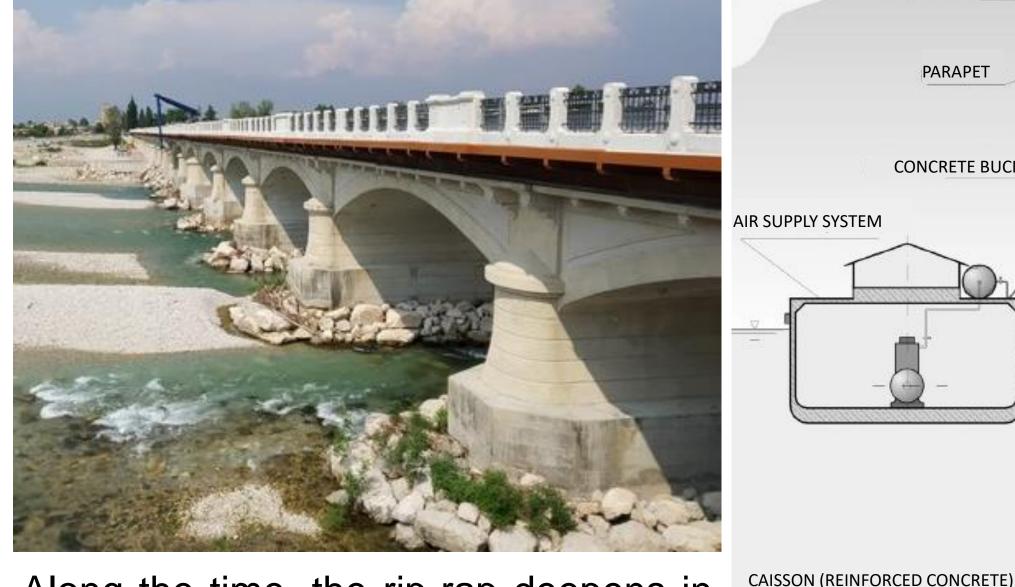
Priula bridge, Piave river, Susegana (TV), Italy

AIR LOCH

CONCRETE BUCKE

Along the time, the rip-rap deepens in sand/silt riverbed material, assuming an inverted **conical shape**.

aly an inverted <b>conical snape.</b>		ANCHOR COLLAR
27.66 27.66 INE A MONTE (1998) 16.86 10.51	FLOW F	ed CUTTING EDGE

In Italy bridges rebuilded after 2nd world war has been characterized by large pneumatic caisson, and only after 1960 the use of pile foundations has been widely adopted.

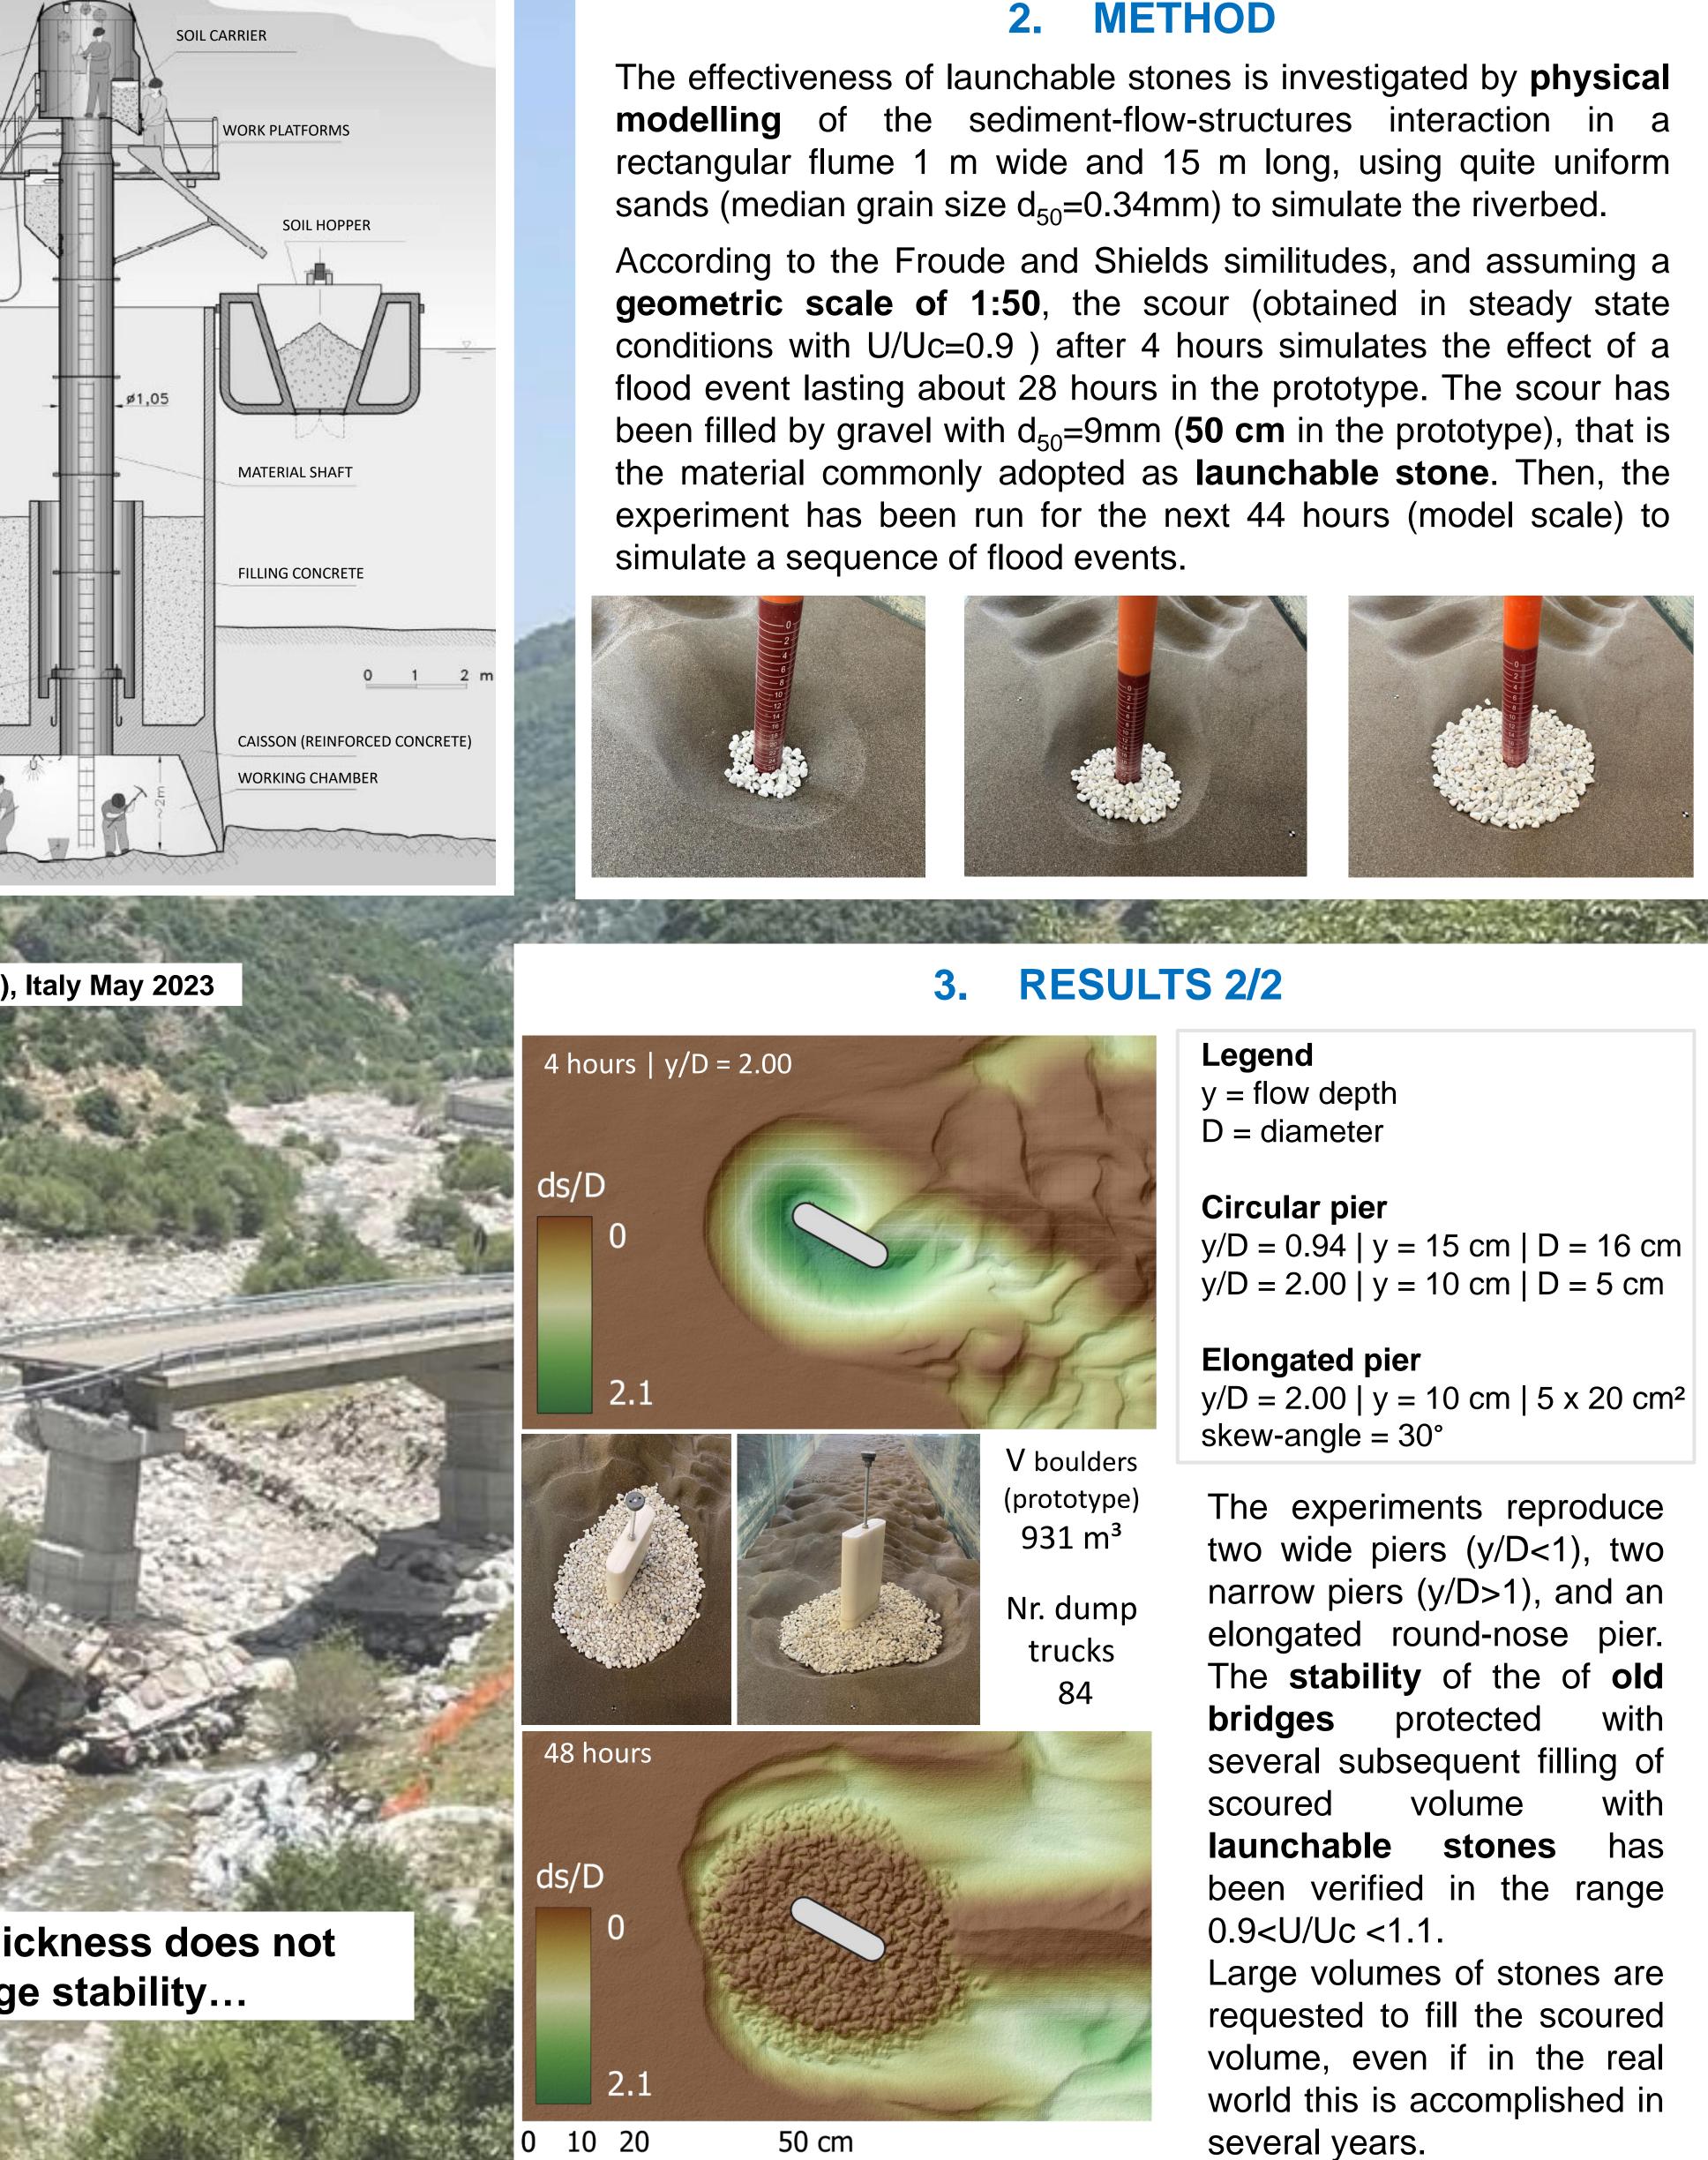
Trionto bridge, Longobucco (CS), Italy May 2023

A mattress of limited thickness does not guarantee the bridge stability...
