RC TIED-ARCH BRIDGES: TYPOLOGICAL ANALYSIS FOR THE DEFINITION OF RETROFIT INTERVENTIONS

Valentina Pernechele¹, Elisa Saler^{2,3}, Francesca da Porto³ and Claudio Modena¹

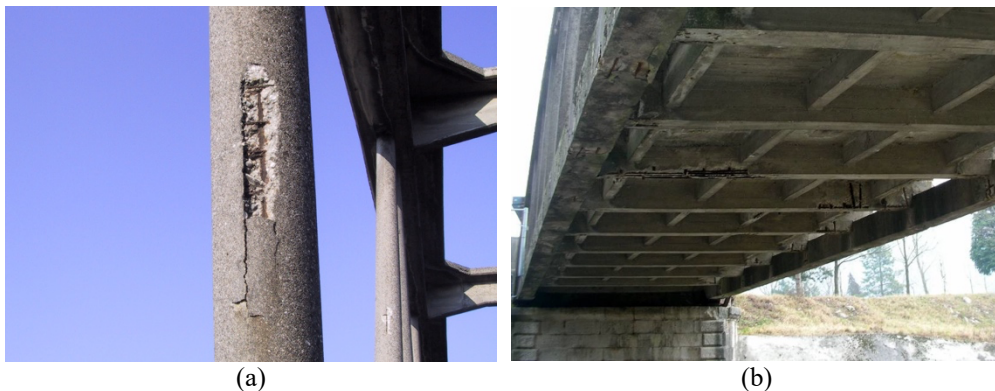
Figure 5: Spalling of concrete and corrosion of exposed rebars on: a) r.c. hanger and b) deck [25].

The effects of degradation are caused by environmental actions (i.e., physical, chemical, and biological), and aggravated by many factors, such as incorrect construction details, low quality of materials, and lack or insufficient maintenance. The main and most common effect of degradation on r.c. bridges is the spalling of concrete, with consequent corrosion of the exposed reinforcement bars. Besides the susceptibility to degradation of all the elements of a r.c. tied-arch bridge, the observation of this phenomenon [26] suggests that hangers and deck structure are the most affected elements (Figure 5). To preserve both deck system and substructures, an effective system to drain rainwater is needed. In the case of steel hangers, the degradation of the material can cause the relaxation of hangers, with consequent redistribution of stresses, and the damage of anchors, which might lead to the detachment of the relative hangers.

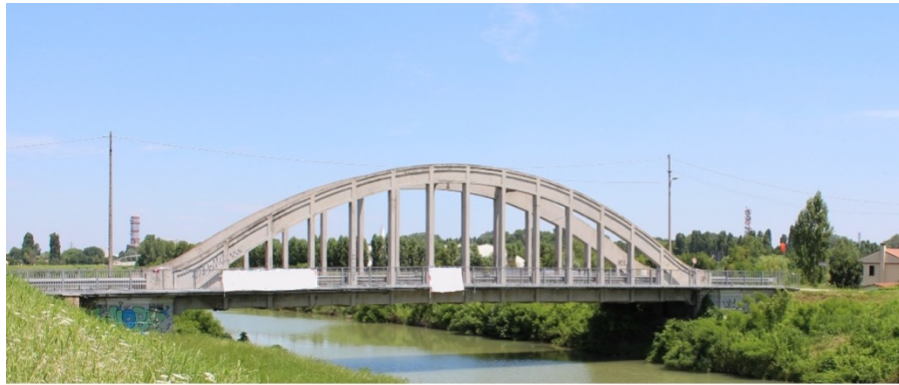
Figure 6: Case study – r.c. tied-arch bridge.

based on representativeness criteria, as it has a series of widespread characteristics, previously illustrated in the national dataset presentation. In detail, it is a single-span bridge, with a span length of almost 40 meters; it has r.c. vertical hangers (spacing 2.5 meters) and three orthogonal r.c. crossbeams (Figure 6 and 7). The deck consists of longitudinal and transverse beams, and a slab. The r.c. abutments founded on piles.

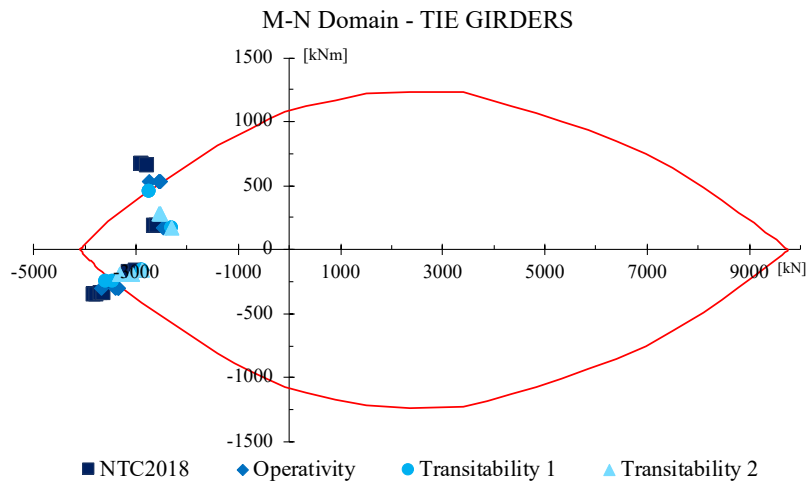
Figure 11: M-N limit domain of tie-girders with plotted outcomes of static analyses.

Figure 11 compares outcomes from the analyses in terms of axial load and bending moment with the limit domain of tie-girders.

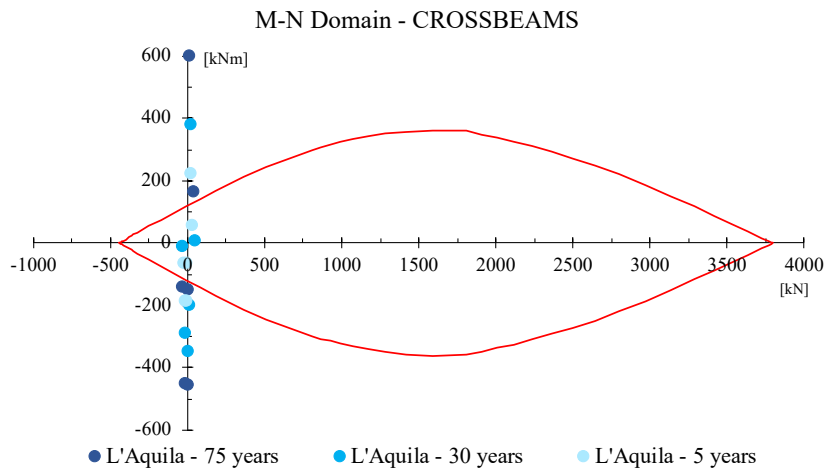
Figure 13: M-N limit domain of crossbeams with plotted outcomes of seismic analyses.

According to the results of seismic verifications, the most stressed elements are the crossbeams, which have the function of preventing the out-of-plane instability of the arches. Crossbeams appear to have a significant seismic vulnerability, showing inadequate safety indexes also for low seismic actions (Figure 13). In addition, tie-girders shows a deficiency for seismic actions as well. Figure 14 reports the results of seismic verifications in terms of minimum demand/capacity ratio for each structural member.
