Head Office: Università degli Studi di Padova

Ph.D. COURSE IN: Geosciences

**DIAGNOSTIC AND EXPERIMENTAL APPROACHES FOR THE CONSERVATION OF GYPSUM  
REPLICAS: FROM INDOOR CLIMATE ASSESSMENT TO AGEING-INDUCED MATERIAL  
TRANSFORMATION**

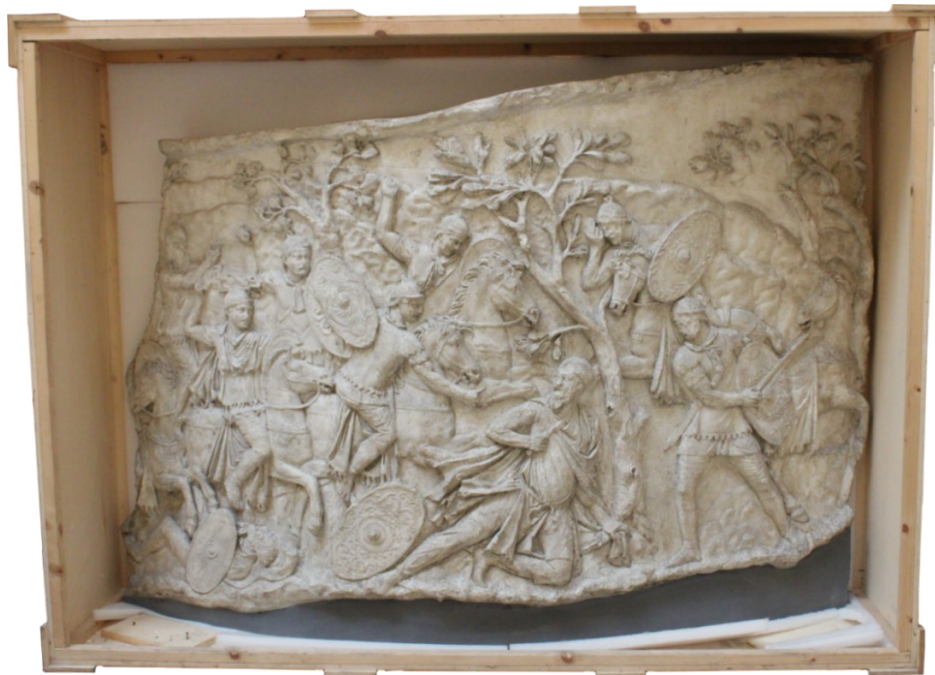
Figure 4. Plaster cast MCR\_3135, recently restored and without evident alterations at the time of the survey.

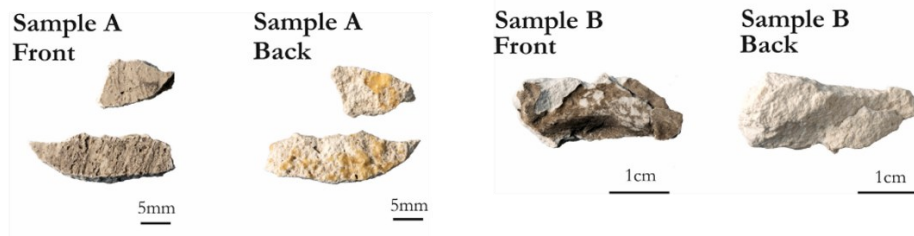
Figure 5. Front and back view of the micro-samples collected from plaster cast MCR\_3045. Sample A was taken from the inner bulk, while sample B corresponds to the surface layer. The image was previously published in *Bubola et al., 2024* [1].

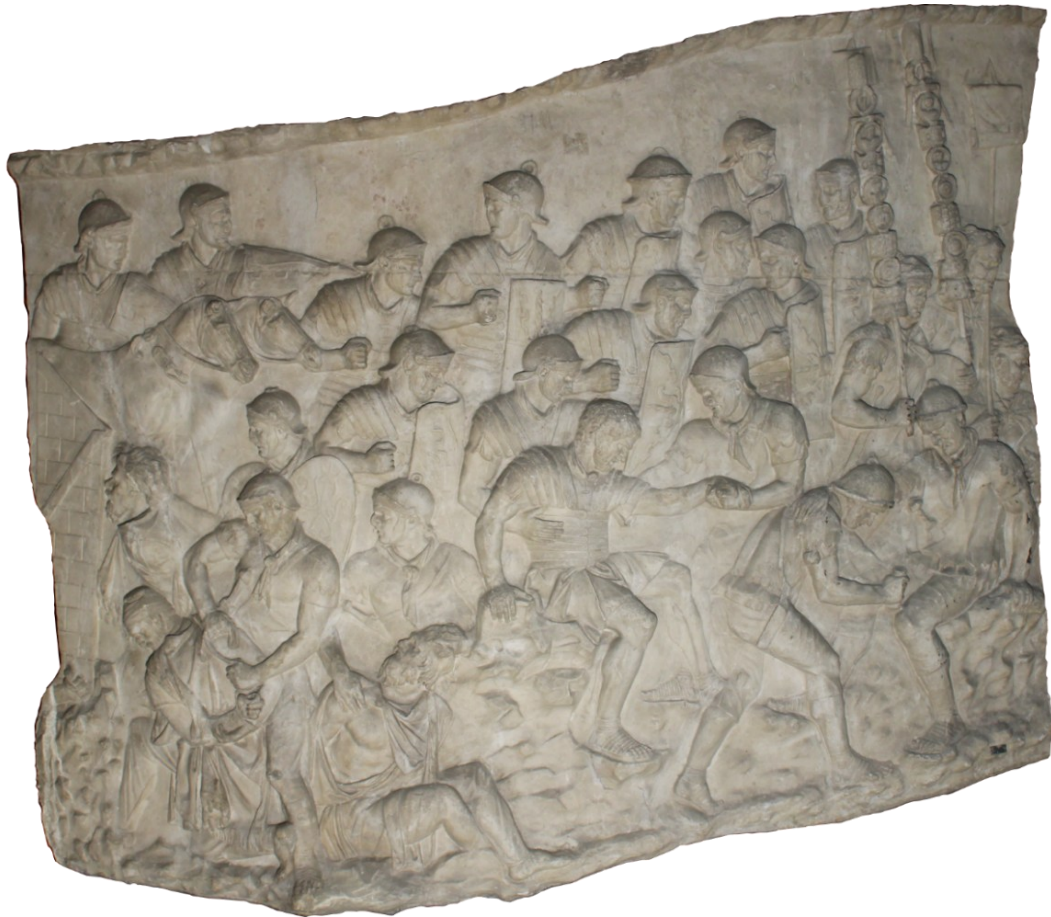
Figure 11. Plaster replica MCR\_3052, reproducing scene 37 of Trajan's Column, conserved in Room LI of the Museum of Roman Civilisation (Rome). The relief shows Emperor Trajan receiving a group of Dacian prisoners, with a Roman military hospital depicted on the right. This cast was selected as a representative case study for on-site diagnostic investigations due to its complex degradation condition and classification in the *poor* conservation category.

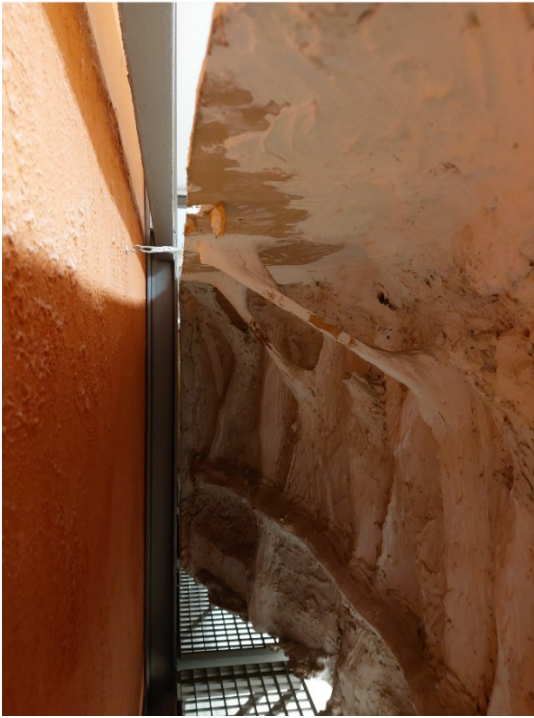
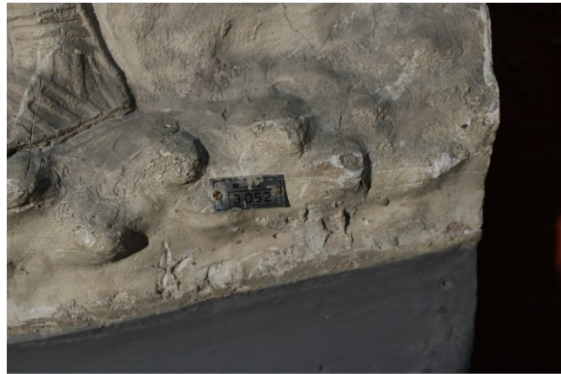
Figure 12. Photographic documentation of plaster cast MCR\_3052. A: partial view of the reverse side of the cast, showing the supporting structure and traces of gypsum application; access to the back was limited due to the cast's position near the wall. B: detail of the lower right edge of the cast, displaying the identification label "MCR 3052" embedded in the surface.

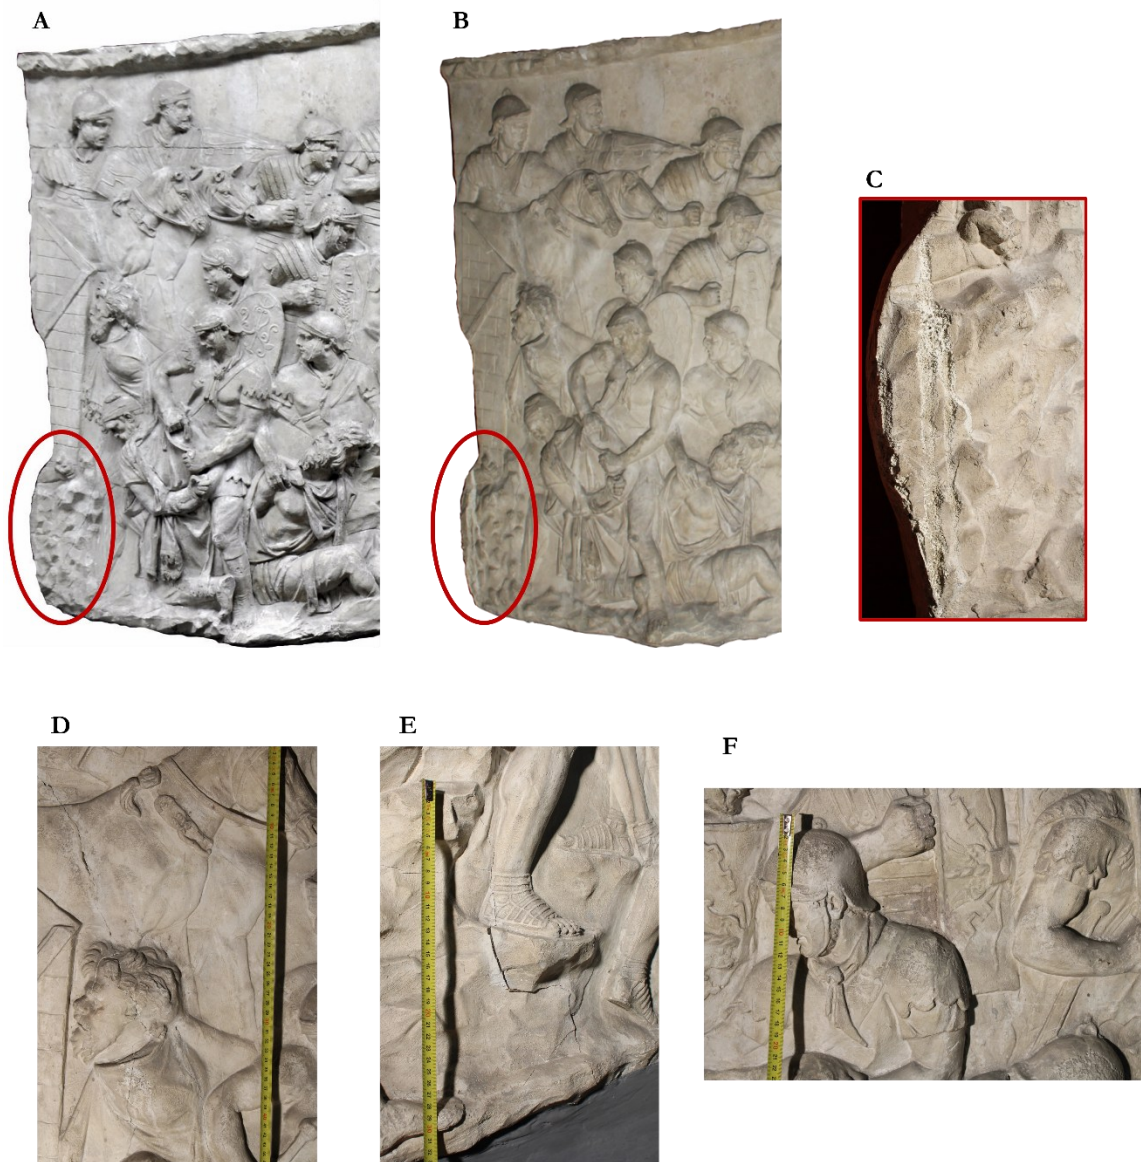
Figure 14. Comparative documentation of the plaster replica MCR\_3052, reproducing Scene 37 of Trajan's column. A: archival photograph from the 2012 survey, showing the left portion of the cast in a relatively preserved condition; B: current photograph taken during the 2023 on-site diagnostic campaign, where visible surface erosion is now evident in the same area (circled in red); C: detail of the eroded edge, showing granular loss and deterioration of the surface profile (also published in *Bubola et al., 2024*); D-E: details of structural fractures and areas filled during previous restorations, measuring tape included for scale; F: area displaying surface alterations, including tonal variations, dark stains, and pencil marks.

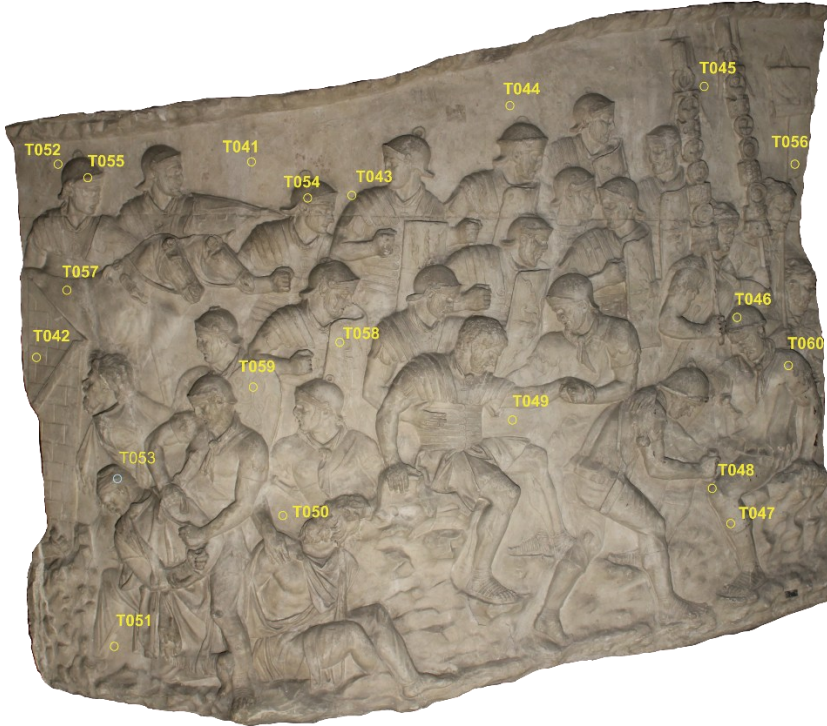
Figure 15. Colourimetric measurement points (T\_041 to T\_060) on the surface of plaster replica MCR\_3052, acquired in the CIELab\* colour space. The distribution of points was designed to sample areas with varying surface conditions to assess chromatic alterations.

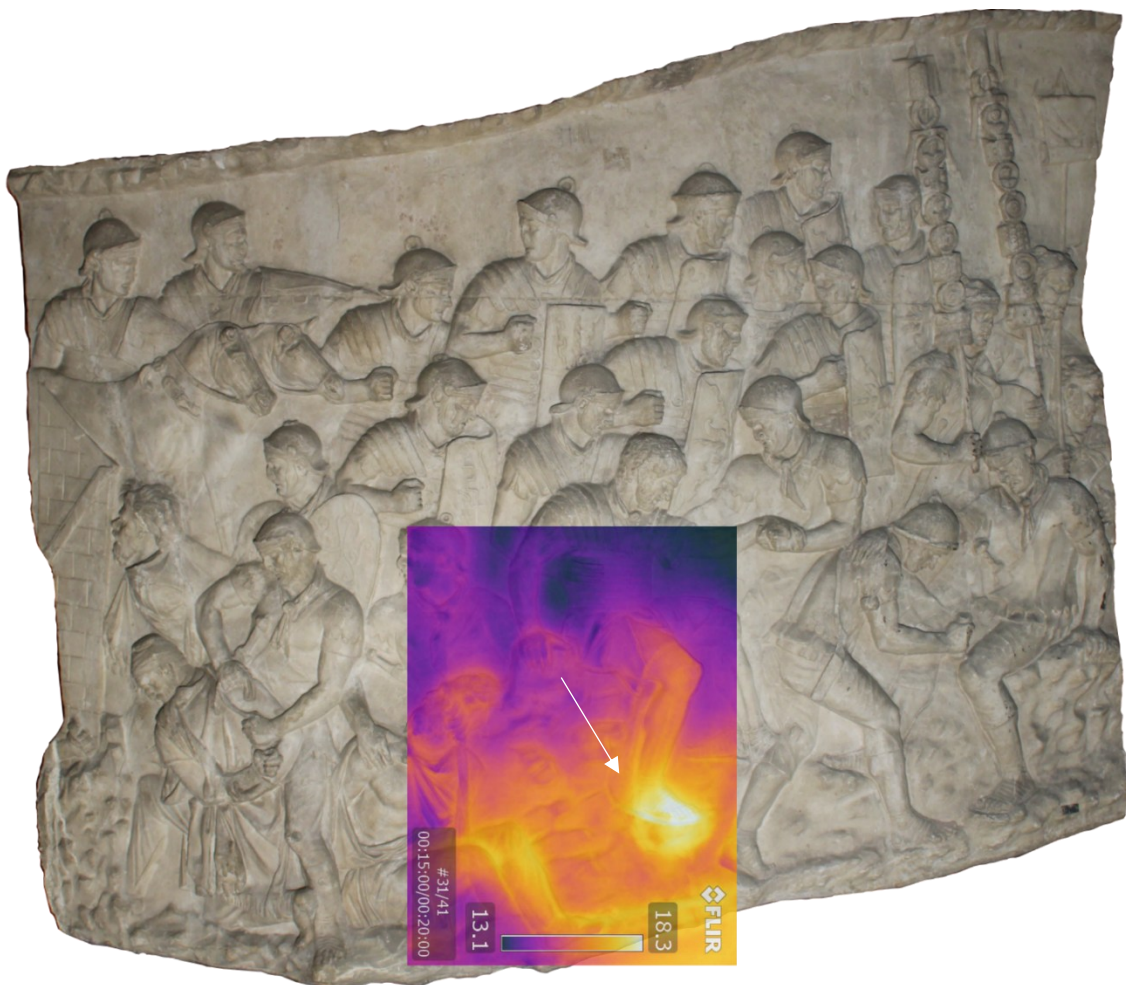
Figure 16. Overlay of the plaster replica MCR\_3052 with the active infrared thermographic acquisition. The thermogram, obtained during a time-lapse cooling phase, reveals thermal patterns in the central area of the cast. The vertical zone with higher thermal response (yellow-orange tones) corresponds to a known fracture, as indicated by the white arrow, while other variations in thermal behaviour may indicate material inconsistencies or prior restorations not visible in standard imagery.

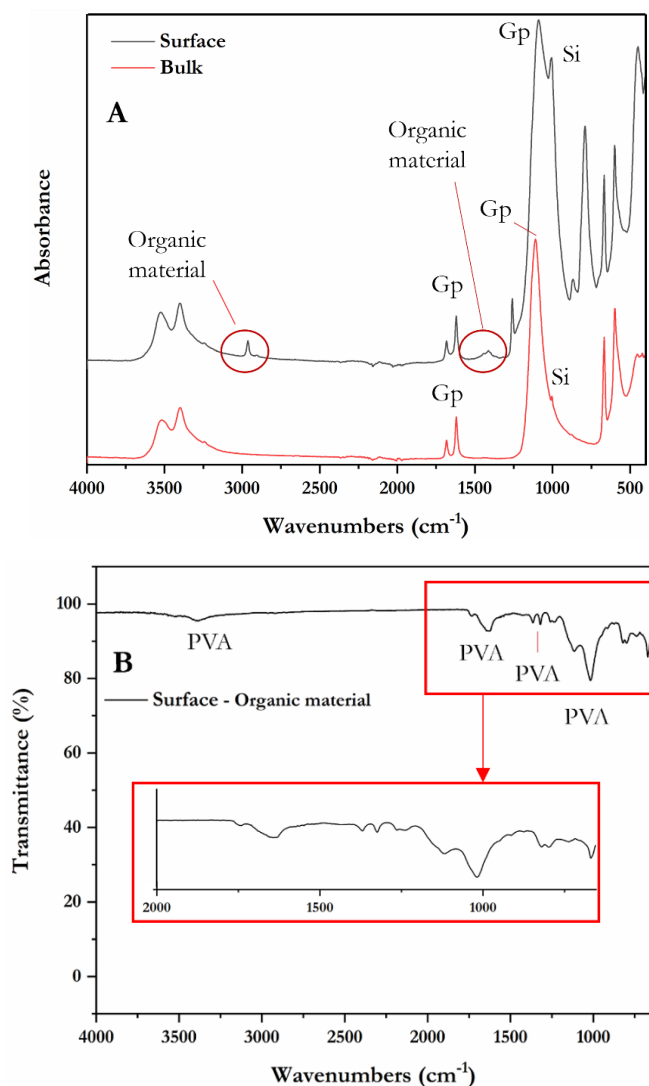
Figure 21. A: ATR-FTIR spectra of the bulk (red) and surface (black) samples from plaster cast MCR\_3045. Characteristic bands of gypsum (*Gp*), calcite (*Ca*) and silicates (*Si*) are observed in both spectra. The surface spectrum additionally showed bands associated with an organic component (highlighted in red circles). B: ATR-FTIR spectrum acquired from the organic layer on the surface of sample B. The spectrum showed absorption bands consistent with those of polyvinyl alcohol (PVA). The inset in red provides an enlarged view of the diagnostic region, allowing clearer visualisation of the characteristic PVA absorptions.

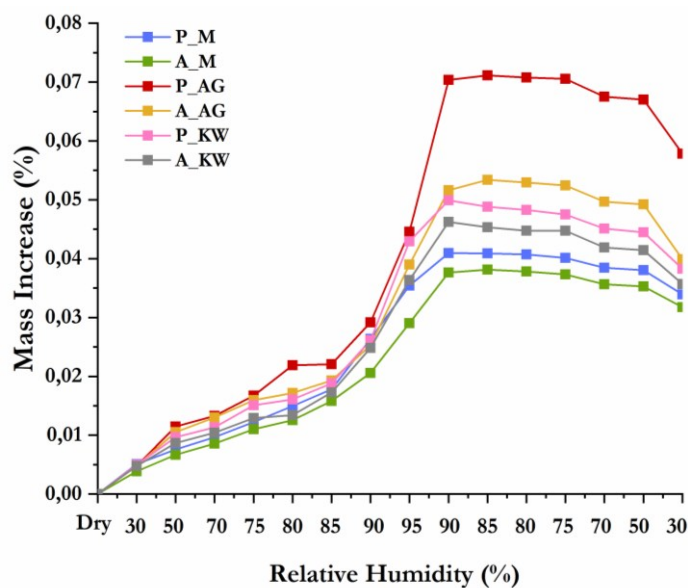
Figure 41. Hygroscopic adsorption and desorption curves of gypsum-based samples with different formulations. the graph shows the percentage increase in mass at equilibrium for each relative humidity step (30-95% adsorption; 95-30% desorption).
