AN INVENTORY OF UNREINFORCED LOAD-BEARING STONE MASONRY BUILDINGS IN NEW ZEALAND

SUMMARY

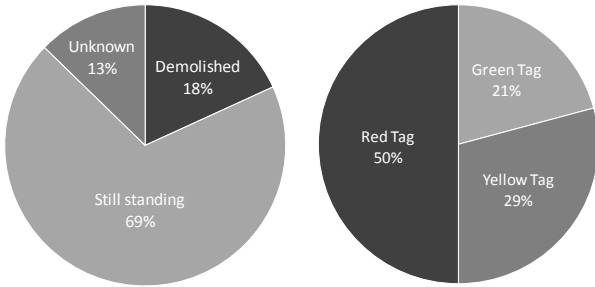
(a) State of URSM buildings (b) Distribution of safety evaluation placarding for 69% of buildings still standing

Figure 1: Condition of URSM building stock in Christchurch after the 2010/2011 Canterbury earthquakes – data updated June 2013.

Following the 2010/2011 Canterbury earthquakes 18% of the stone masonry buildings in Christchurch were confirmed as being demolished due to safety reasons (Figure 1a) with the

fate of an additional 13% being unknown at the time of the study. For the remaining 69% of URSM buildings in existence in Christchurch prior to the earthquakes (Figure 1b), only 21% were classified as having low damage (green placard) whereas 50% were classified as heavily damaged, corresponding to categories D4 and D5 in accordance with the EMS-98 scale [4, 5, 6]. Most of the observed damage was attributed to the poor quality of constituent materials (particularly weak mortar) and/or the lack of interconnectivity between masonry leaves, see Figure 2 to Figure 6. Close examination of damaged URSM buildings allowed further investigation of historic construction methods and wall cross-section morphologies, being information that is typically only attained via destructive investigation methods. The performance of URSM buildings that had received seismic strengthening was also investigated following the Canterbury earthquakes [7].

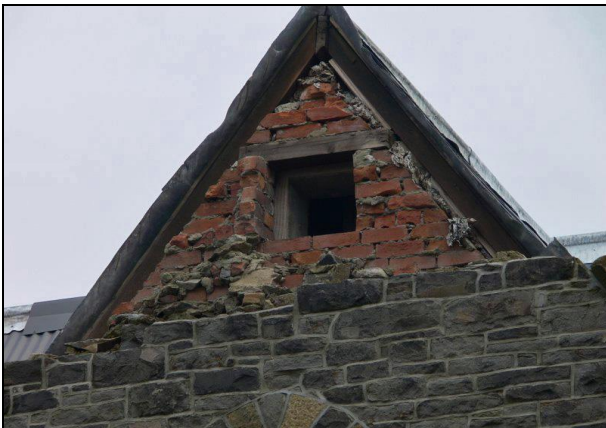
Figure 3: Canterbury Provincial Council Buildings, Bellamy's (1864). Halswell basalt facing with clay brick backing wall. Out-of-plane partial collapse of a gable due to the absence of bond between leaves.

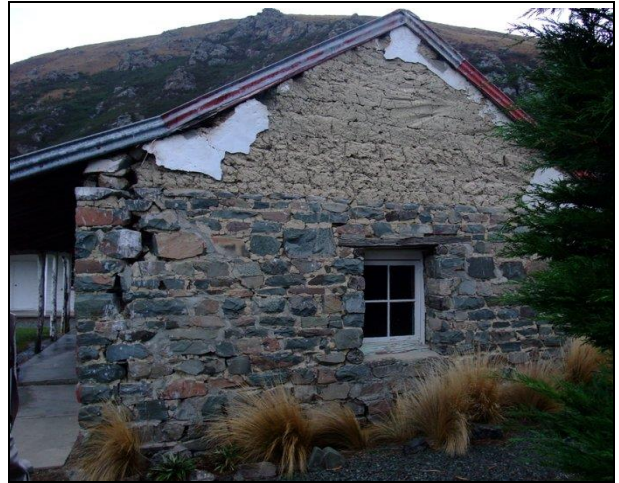
Figure 4: Hakatere Station (1862) greywacke rubble walls with mudstone gables. Lack of bond between walls with activation of out-of-plane mechanism.

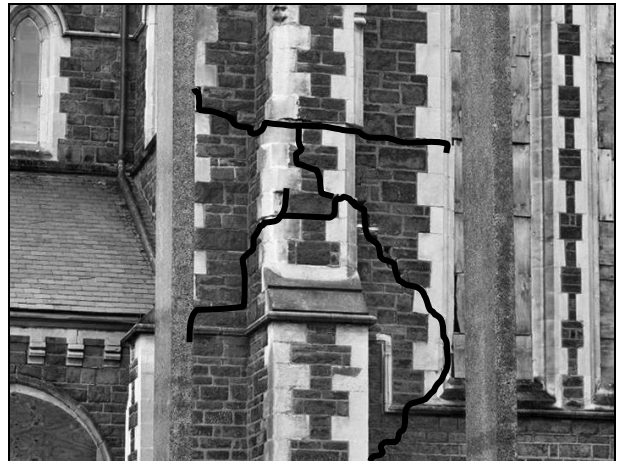
Figure 5: Cathedral Church of Christ (1864), Christchurch. 3 leaf basalt (from Banks Peninsula) wall and limestone ornamentation. In-plane failure shown by diagonal cracking (highlighted for clarity) and twisting of the buttress.

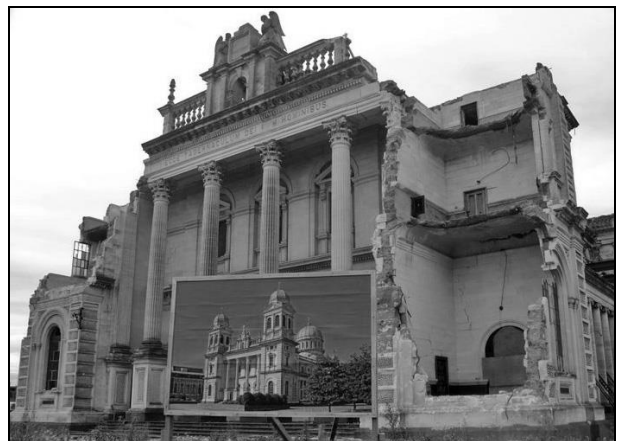
Figure 6: Cathedral of the Blessed Sacrament (1899), Christchurch. Oamaru limestone facing with cast in-situ no-fines concrete core walls. Collapse of the towers due to inadequate lateral resistance of the masonry walls.

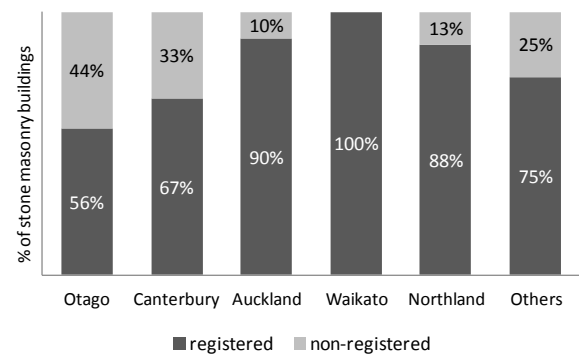
Figure 7: *Percentage of existing stone masonry buildings registered with the New Zealand Historic Places Trust (NZHPT), where “others” refers to regions with a low percentage of URSM.*

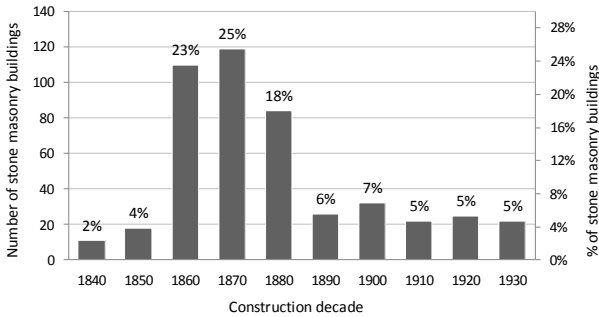
Figure 8: Construction decade of URSM buildings in New Zealand.

During data collection and documentation 688 URSM masonry buildings were identified, including 20 URSM buildings which were demolished following the 2010/2011 Canterbury earthquakes. Approximately 65% of the existing URSM stock was built between 1860 and 1890, see Figure 8. The use of natural stone was particularly common for the construction of public facilities such as churches, schools and universities, government properties (courthouses, chambers, courts, boundary markers, fortresses, lighthouses, prisons) and civic facilities (museums, libraries, stations, post offices, theatres, banks). Many of the earliest settlements were also constructed using natural stone, especially in the Otago countryside. Clusters of buildings and estates were built following a traditional code of practice and were used as rural houses, farms, manufacturing facilities and settlements.

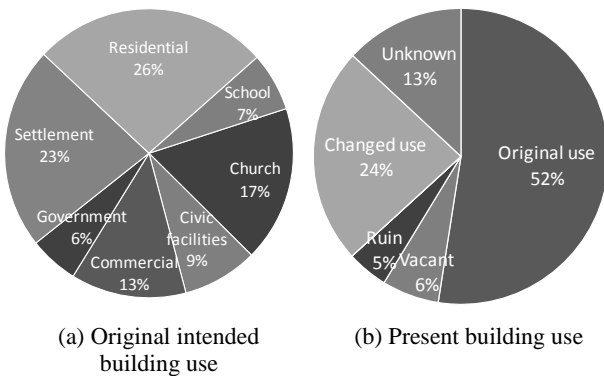
Figure 9: URSM building usage statistics.

Natural stone was also used for the construction of hotels, restaurants, warehouses and shops where townships were expanding. As shown in Figure 9a, approximately 62% of the existing URSM buildings were constructed for private use (settlements, residential and commercial use), whereas 38% of the buildings were constructed as public facilities.

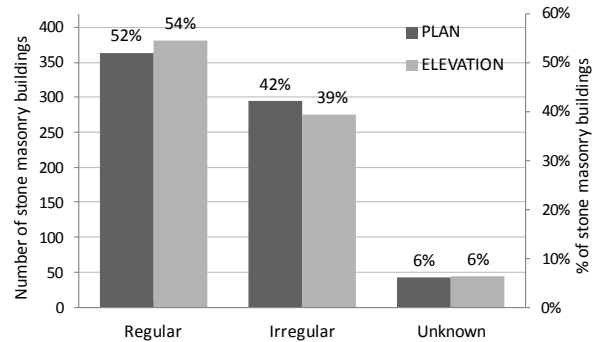
Figure 10: Presence of regular and irregular URSM building layout, both in plan (dark grey) and in elevation (light grey).

data collection stage. A building was considered regular in plan when the foot-print area was comparable to a simple geometric shape. Buildings with a ‘T’, ‘L’, or ‘U’ shaped foot-print and/or buildings with multiple projections were considered as irregular in plan. A building was considered regular in elevation when the floor height was similar in all its parts without projections, and there was an absence of ornamental structures (such as pinnacles, spires, flying buttresses, dome lanterns, and other similar features). It was observed that the majority (approximately 54%) of existing unreinforced stone masonry buildings in New Zealand are regular in both plan and in elevation and typically consist of one or two storeys. Connections between load-bearing walls or between walls and floors or roof are commonly insufficient. Timber floors and roofs are typically present in URSM buildings. The foot-print area data was clustered into 6 value ranges, with a large number of the documented URSM buildings (40%) having an area ranging between 51 to 200 m², while 25% have a smaller floor area and typically consist of huts, barns, stables, sheds or other farm buildings. 16% of the URSM buildings consist of a foot-print area ranging between 201 to 500 m², typically consisting of public buildings constructed in the city centres. Figure 10 to Figure 12 shows graphical representation of the results.

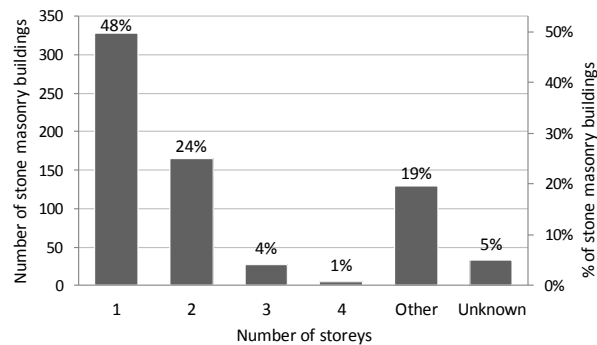
Figure 11: Number of storeys for existing URSM buildings. The category “other” reports all buildings with high open space and large gable walls, typically being churches and halls.

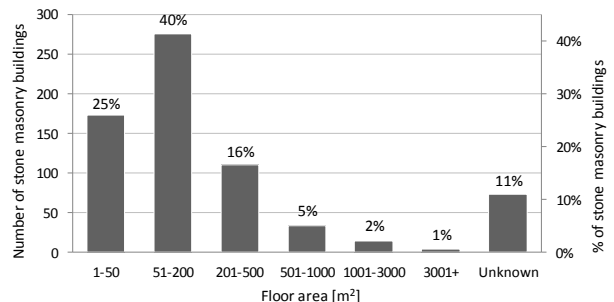
Figure 12: Approximate foot-print area in m² of existing URSM buildings.

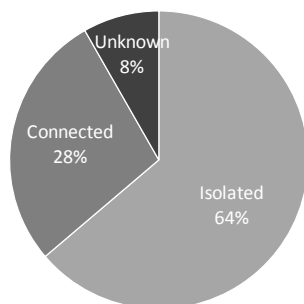
Figure 13: Presence of isolated and connected (including in a row and clustered) URSM buildings.

An important factor that influences the global seismic performance of URSM buildings is the interaction with neighbouring buildings, also known as pounding effects [1]. It has been shown in previous earthquakes that isolated buildings belonging to the same age and type of construction frequently exhibit different failure mechanisms when compared to row buildings [18, 19]. In order to evaluate the possibility of pounding, a distinction between isolated and connected buildings was identified and documented in the inventory. Figure 13 shows that there are more isolated URSM buildings (64%) than connected buildings (28%), with the latter category including both row and clustered buildings. Small townships in the Otago countryside were typically built using URSM buildings and were arranged in a row or cluster with minimal use of timber construction.

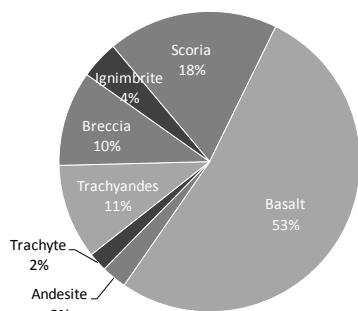
Figure 14: Usage of igneous rock sub-types as construction material in New Zealand.

Igneous sub-types used in construction (see Figure 14) were basalt and scoria (or tuff) extracted in Auckland, Bay of Islands, and Banks Peninsula (see Figure 15), trachyandesite from Leith Valley (see Figure 16), trachyte from Banks

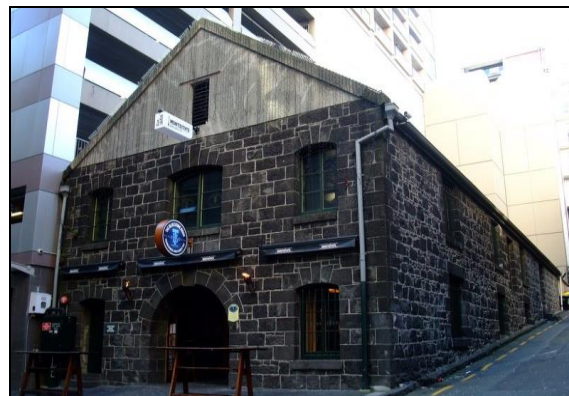
Figure 15: Bluestone Store in Auckland, 1861, built using local basalt.

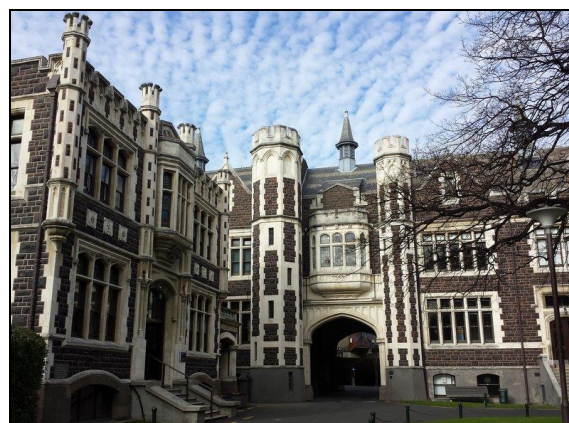
Figure 16: University of Otago in Dunedin. Built between 1878 and 1923 with Leith Valley trachyandesite and Oamaru limestone as ornamentation.

in construction (22% of the URSM building inventory) and for building ornamentation, such as around openings, corners, pillars, stringcourses and spires (see Figure 16). Selective examples of URSM buildings constructed in north-east Otago using limestone are shown in Figure 18 to Figure 20.

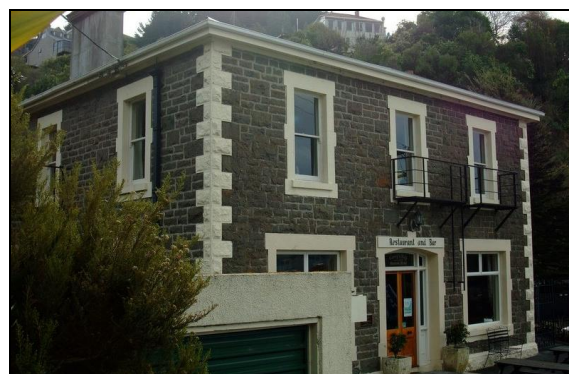
Figure 17: Carey's Bay Hotel in Port Chalmers, built in 1874 using local breccia.

Peninsula, New Plymouth andesite, Port Chalmers breccia (see Figure 17) and Waikato ignimbrite [13, 14]. The properties (colour, density, porosity, compressive strength, etc.) of each type of natural stone vary depending on the quarry where the stones were extracted and consequently result in varying rates of deterioration [20, 21].

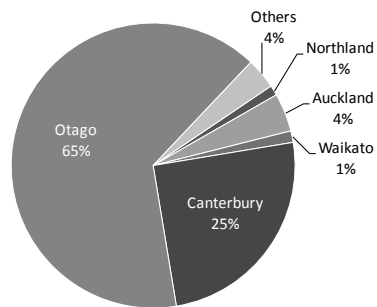
Figure 24: *Estimated provincial populations of stone masonry buildings in New Zealand.*

The majority (92%) of the identified URSM buildings are concentrated in the South Island, with 65% of the buildings being located in Otago and 25% of the buildings being located in the Canterbury region (data from prior to the 2010/11 Canterbury earthquakes, where 20 stone masonry buildings were demolished due to the heavy damage suffered), see Figure 24. Mapping of the recorded data showed that the use of construction stone types was directly related to the local geology (see Figure 25).

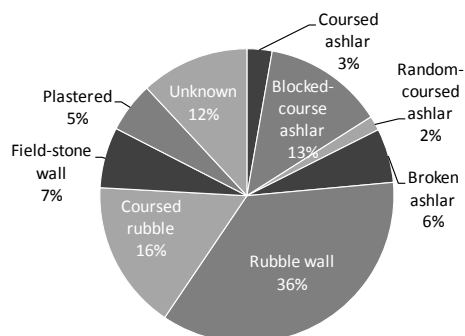
**Figure 26: Prevalent stonework used on the texture surface of the URSM buildings in New Zealand.**

The texture classification method presented by Lowndes [22] was used in this study to identify the recurring stone masonry typologies in New Zealand (see Figure 26). Ashlar and rubble stonework are the two main surface texture categories. Ashlar texture refers to natural stones that are cut on four sides with the adjoining sides oriented at right angles to each other, having straight and horizontal mortar bed joints, and with the

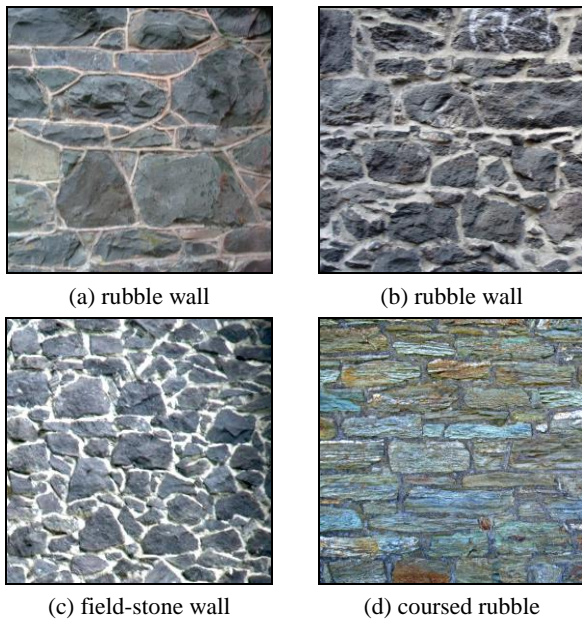
Figure 28: *Examples of rubble stonework in New Zealand: basalt wall in (a) the church of the Holy Innocents, Mt. Peel; (b) the Bluestone Store, Auckland; (c) Kinder House, Parnell; and (d) schist wall, St. James church in Roxburgh.*

The rubble type of surface texture refers to natural stones in which the adjoining sides are not required to be oriented at right angles. Such stonework is generally laid with mortar joints dressed with strong cement based pointing mortar. It was identified that structural mortar is likely to be weak or locally absent. Natural rubble stones are set irregularly in the wall and the interstices are filled with spalls and mortar [22]. Typical rubble stonework that was identified included rubble walls (36%, Figure 28 a-b), field-stone walls (7%, Figure 28c) and coursed rubble (16%, Figure 28d). In central Otago, schist is a particular case of texture surface where the typical foliation makes it difficult to cut ashlar stone. Schist was commonly used as rubble stonework but a refined ashlar stonework finish with regular mortar joints was sometimes superficially simulated (see Figure 29). Several examples of a simulated ashlar surface texture were identified in the Fruitlands area (central Otago), Alexandra and Clyde.

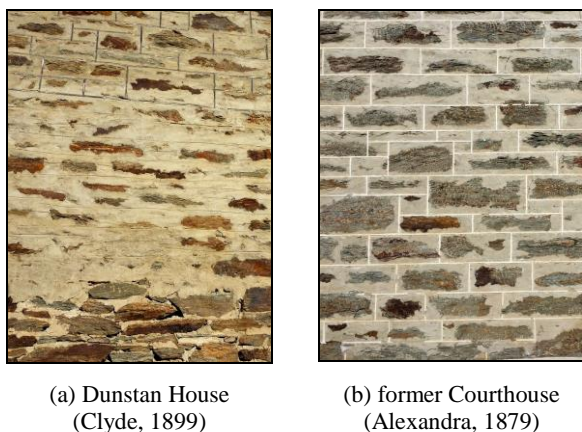
Figure 29: *Representative examples of rubble wall built using local schist and simulating a broken ashlar surface texture.*

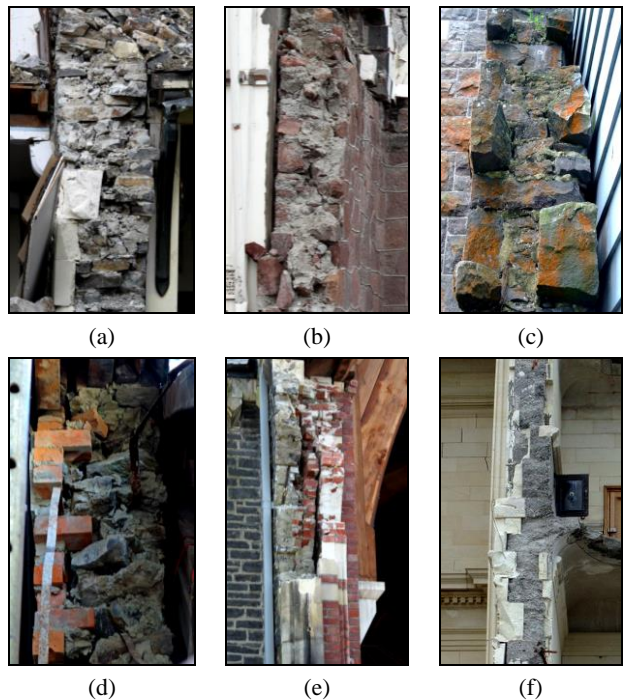
Figure 30: *Typical unreinforced stone masonry cross-section in New Zealand. 3 leaves with rubble fill in (a) the Trinity Church and (b) the Provincial Chambers towers, Christchurch; (c) 3 leaves with headers in St Paul's Church, Auckland; stone front façade with clay brick back leaf in (d) Bellamy's and (e) St Luke's Church, Christchurch; (f) stone facing with cast in-situ no-fines concrete core in the Cathedral of the Blessed Sacrament, Christchurch.*

A combined arrangement of natural stone facing and clay brick backing (see Figure 30 d-e) was observed to be a common construction technique used in city centres and it is highly likely that a similar technique was used for the construction of iconic URSM buildings in several centres including Christchurch, Dunedin and Auckland. Combining two constituent construction methods resulted in simplified and accelerated construction, thereby reducing the construction cost of large and complex buildings when compared to the use of stone masonry construction only. Some examples of combined construction are the Arts Centre in Christchurch and the University of Otago in Dunedin, where the grandeur was obtained by constructing the building façade using natural stone but the less visible walls were constructed using only clay brick masonry (Figure 31). Another example of mixed construction is the Cathedral of the Blessed Sacrament in Christchurch where the walls were built using two leaves of ashlar Oamaru limestone and a cast in-situ no-fines concrete core (Figure 30f).

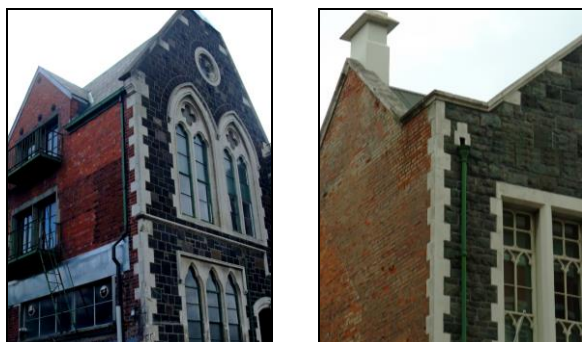
(a) The Arts Centre in Christchurch

(b) The University of Otago in Dunedin

Figure 31: Buildings constructed using a combination of stone and clay brick masonry.
