Post-Earthquake Reconnaissance of Unreinforced and Retrofitted Masonry Parapets

Marta Giarretton,^{a)} M.EERI, Dmytro Dizhur,^{b)} M.EERI, Francesca da Porto,^{a)} and Jason M. Ingham,^{b)} M.EERI

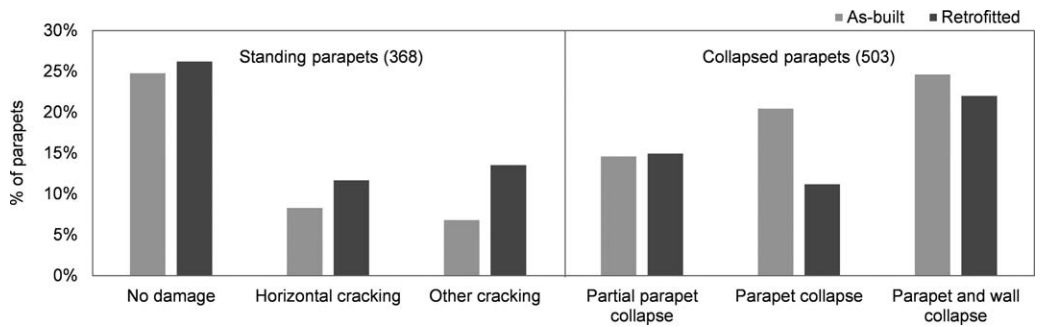
parapets presented an increased occurrence of horizontal or other cracking failures (Figure 17). After the 22 February 2011 event, 40% (269) of the as-built parapets were standing while 60% (403) had collapsed. Retrofitted parapets presented a slightly better performance with 52% (109) of parapets standing and 48% (100) of parapets collapsed. A large percentage of retrofitted parapets collapsed but it has to be considered that in many cases it was not easy to identify from the street the presence of any retrofit intervention, unless the parapet had partially or fully collapsed. Figure 17 shows the improvement in performance of retrofitted parapets when compared with as-built parapets. Note that a large number of parapets (23%, 212) collapsed due to partial collapse of the facade, and hence the adopted retrofit intervention designed only for the parapet was not able to prevent the failure.

Figure 17. Observed failure categories of as-built and retrofitted URM parapets after the 22 February 2011 Christchurch earthquake.

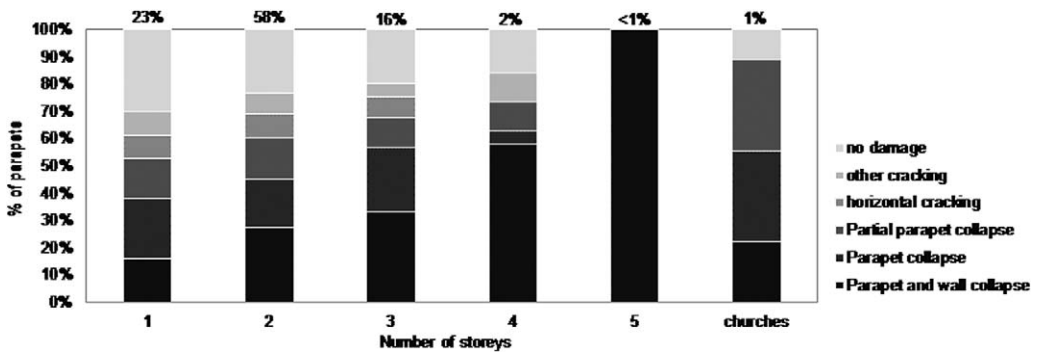
Considering the state of the parapets after the three major earthquake events an increase in the level of damage to parapets proportional to the height of the building (number of stories) was observed as expected (Figure 18). In the case of two story buildings, the most frequent category, 27% (153), of parapets collapsed in conjunction with out-of-plane wall failure, 18% (99) exhibited overturning failure of the parapet and 15% (84) partially collapsed. Of the parapets that remained standing, 9% (48) exhibited the initiation of overturning failure

Figure 18. Observed parapet failure categories and proportion in relation to the number of stories of the building.

indicated by horizontal cracking, 8% (43) had other types of cracks and 23% (130) presented no damage.

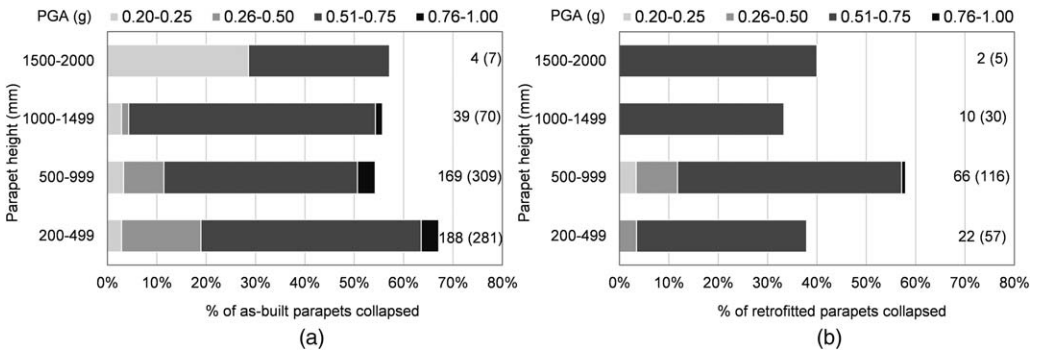
Figure 20. Parapet collapse during the 22 February 2011 Christchurch earthquake in relation to parapet height and the registered PGA: (a) As-built parapets; (b) retrofitted parapets.

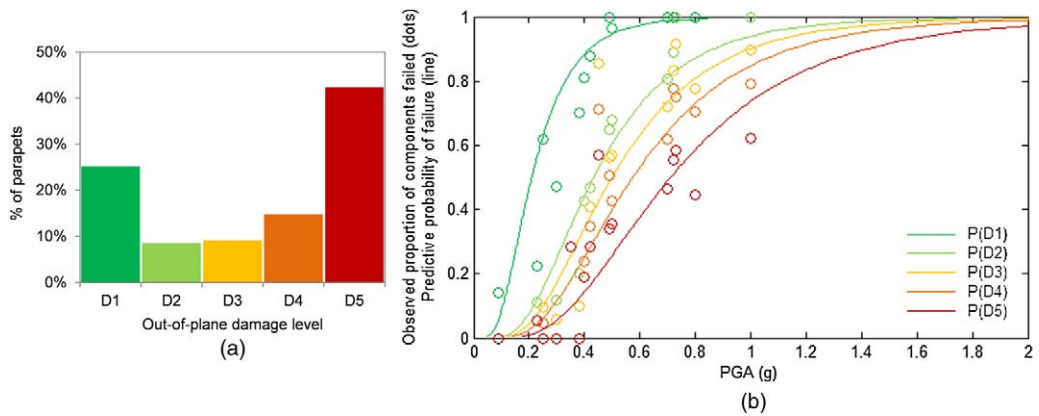
Figure 23. Damage level observed for unreinforced masonry parapets following the Canterbury earthquakes: (a) breakdown of damage levels; (b) fragility curves.

levels, while Figure 23b reports the simulated fragility curves for each level of damage, demonstrating that the median fragility values increase with increasing damage level. The estimated median fragility values are: $P(D1) = 0.21$ g; $P(D2) = 0.43$ g; $P(D3) = 0.50$ g; $P(D4) = 0.57$ g; and $P(D5) = 0.71$ g.

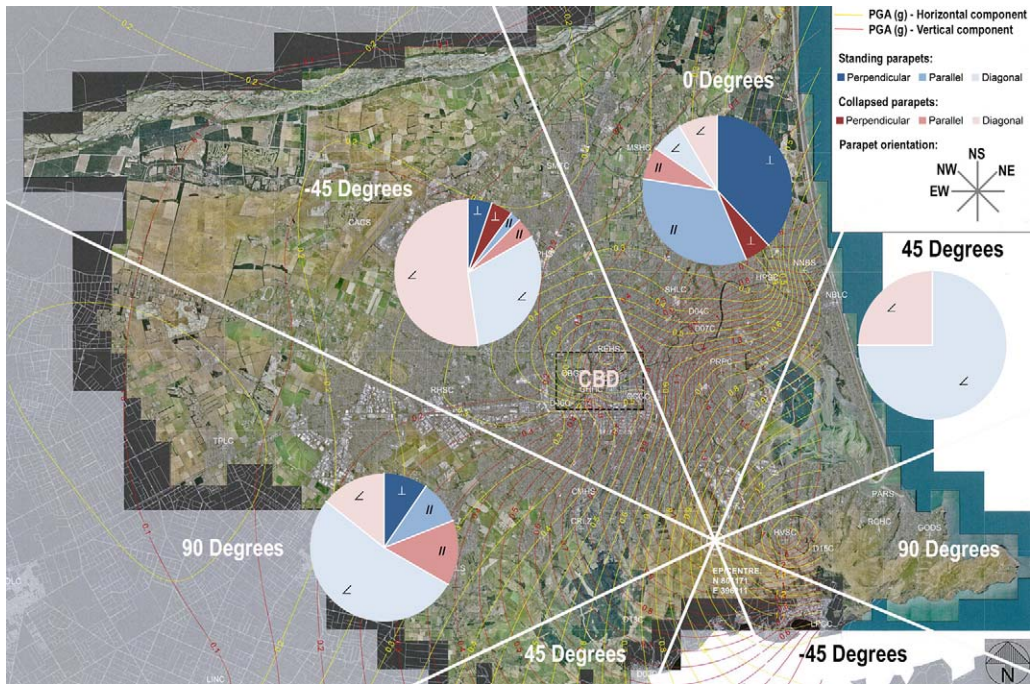
Figure 24. Map showing the epicenter and PGA contours (Source: Christchurch City Council) and for each considered angle group a pie chart showing standing and collapsed parapets for each orientation.

collapsed. Parapets were predominantly oriented perpendicular and parallel to the earthquake direction in the area referred to as “0 degrees,” where only 71 URM parapets were identified. Nevertheless, in the “0 degrees” quadrant a large number of parapets remained standing and it was not possible to assess the influence of the directivity effect because of the distance from the epicenter, being 32 km and 22 km, respectively, for Rangiora and Kaiapoi, where in both cases the recorded PGA was lower than 0.20 g. Table 4 presents the results and the number of parapets considered for each group.
