9th CIRP Conference on High Performance Cutting (HPC 2020)

Anisotropy effect on Laser Powder Bed Fused Ti6Al4V machinability

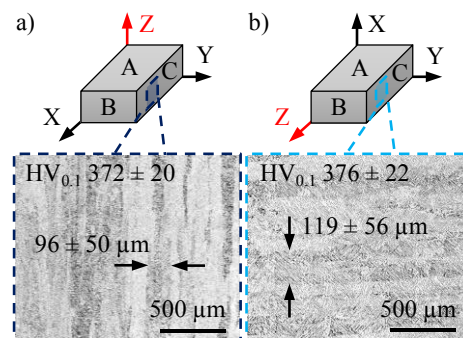
Fig. 2. LPBF Ti6Al4V lateral microstructures of the a) HO and b) VO samples. The build-up direction is along the Z axis, highlighted in red. Microhardness and prior β grains width are also reported.

Fig. 2 reports the LPBF Ti6Al4V blocks configuration and their cross-sectional microstructure after the heat treatment. Long prior β grains developed along the Z axis with continuous α phase layers at their boundaries and α phase (in light) and β phase (in dark) lamellae lying within it, as reported also by Vrancken et al. [9]. The different prior β grains orientation and size reported in Fig. 2 is related to the thermal gradient developing in the AM part. In fact, the β grains grow along the direction of the higher thermal gradient during the AM process, that is the build-up direction. Moreover, lower cooling rates lead to wider β grains [1,2], thus HO and VO samples experienced similar cooling rates at the analyzed height since comparable β grains widths were found.
