6th CIRP International Conference on High Performance Cutting, HPC2014

Machinability Characteristics of Wrought and EBM CoCrMo Alloys

A. Bordin^a, A. Ghiotti^a, S. Bruschi^{a*}, L. Facchini^b, F. Bucciotti^b

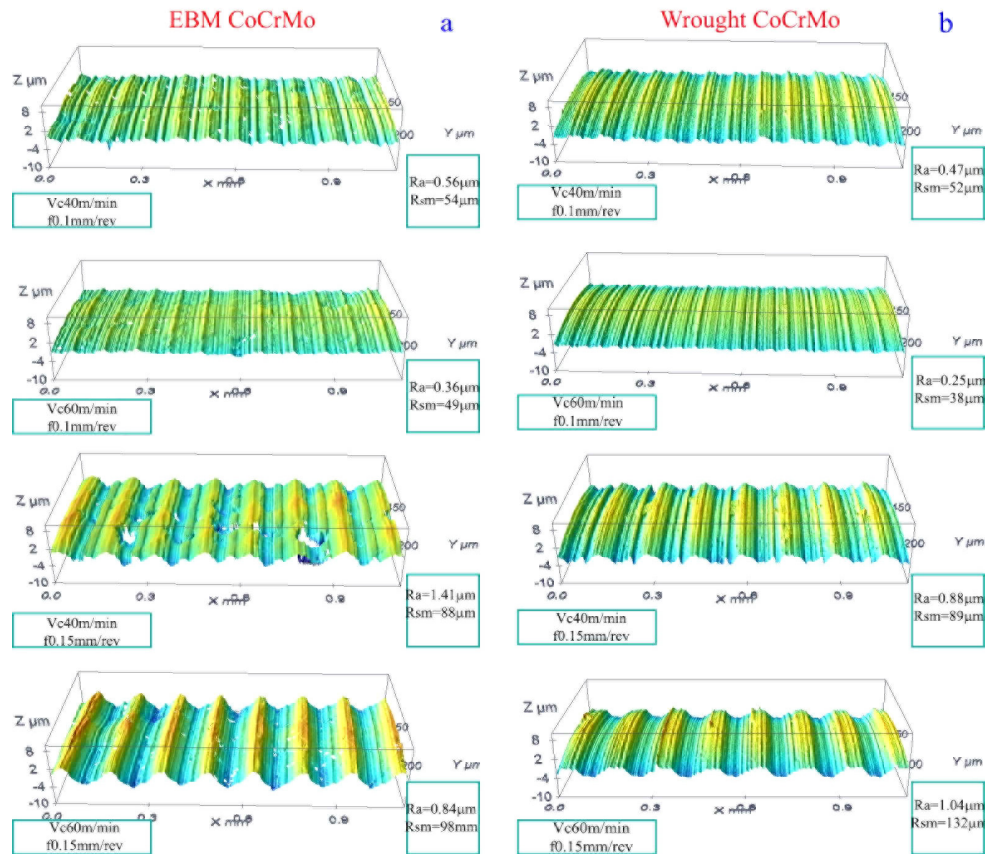
Fig. 5. Comparison between the surface topographies adopting different cutting parameters after 8 minutes of turning : (a) EBM alloy, and (b) wrought alloy.

The surface integrity of machined surfaces is commonly characterized measuring the surface roughness parameter R_a , as well as other parameters defined according to the ISO 4287 – 1997[6] standard. In the last few years, digital optical profilometers were also adopted to analyse the effects of the cutting parameters, cutting tool geometries and different cooling strategies on the machined surface quality. 3D images of the machined surface of both the wrought and EBM alloys after 8 minutes turning are presented in Fig. 5, where the values of R_a and R_{sm} measured with a portable roughness tester are also reported.

3D images of the EBM alloy machined surfaces confirm the results about the tool wear comparison between the two alloys. Even though at the first stages of turning, the EBM alloy R_a values are comparable to those of the wrought alloy, several craters, laps and cracks are present on the machined surfaces between and across the feed marks, making the surface quality not ideal for biomedical applications, where fretting, fatigue and tribo-corrosion resistances are required.

These surface macro defects tends to increase at increasing feed rate, and even a crater of 0.11 mm width and 15 μm depth was measured. Such kind of defects can be caused by the chip formation mechanism, which is not characterized by plastic flow on the primary shearing zone on the insert rake face. The chip morphology obtained for all cutting conditions and for different turning times didn't changed significantly, and chips in form of powder particles were collected. The chips did not undergo any plastic deformation, leading to brittle fracture, and resulting in the formation of a crater. At increasing feed rate to 0.15 mm/rev, the surface roughness increased more than 50% at 15 min of turning compared to the values measured on the wrought alloy. Material side flow and plastic deformation can be observed on the scanned surfaces as for the wrought alloy, no substantial variations were registered in the other time steps, but in the case of the EBM alloy this kind of defects can be considered of secondary importance.
