## The Mt. Peron historical rock avalanche

# Modelling and analysis of possible displacements over the Mt. Peron niche

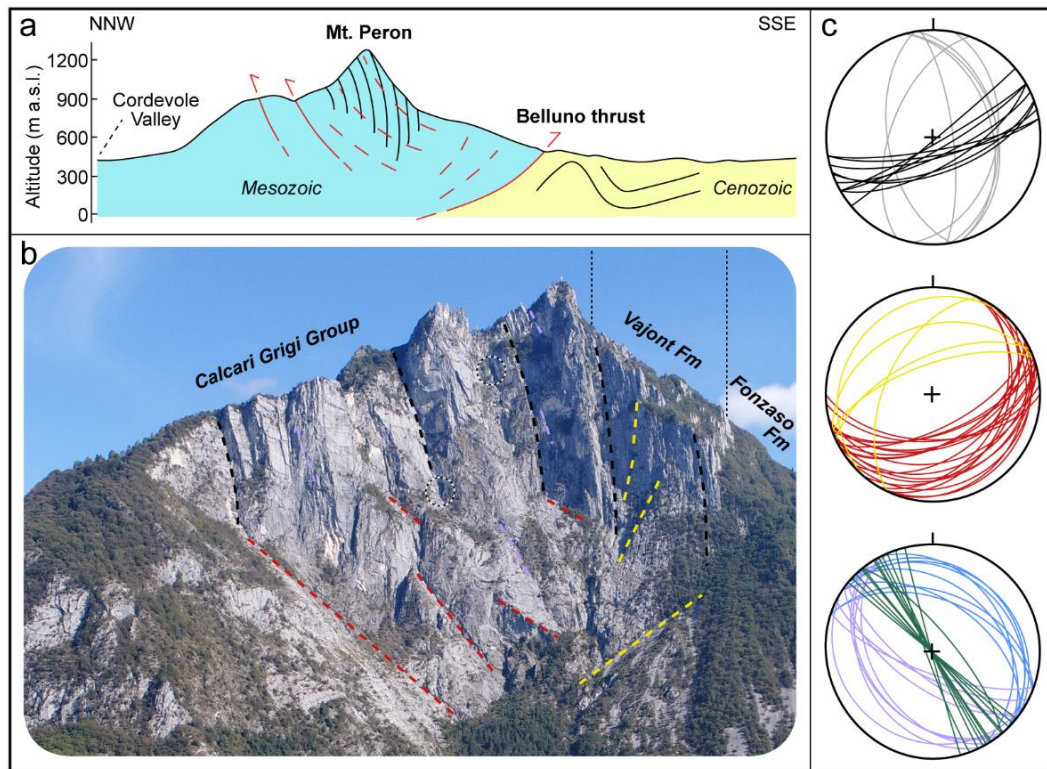
**Fig. 2:** Structural scheme of the Mt. Peron release scarp. **a)** Schematic geological cross-section. **b)** Photograph with major structural elements and larger karst caves (black-and-white circles) highlighted. **c)** Lower hemisphere stereographic projection of principal structural elements. Colours in **b)** and **c)** correspond to the following: bedding (black), N-S Jurassic fault-related planes (grey), basal trenches and other high-angle fractures connected to the Belluno thrust (yellow) and backthrust (red), fractures related to the NNW-SSE fault system (light blue), their conjugates (pink) and high-angle fractures with the same orientation (green). (Source: Rossato et al., submitted)

The western part Mt. Peron is composed of Jurassic and Cretaceous limestones, forming the nucleus of an ENE-WSW oriented anticline with a vertical-to-very steep forelimb, followed southwards by the Belluno syncline (**Fig. 2**). The eastern part of the Mt. Peron is mainly made of Jurassic and Cretaceous limestones and dolomites. Cenozoic formations crop out west of Mt. Peron, including the ENE-trending bedrock ridge of Castel Cuch, which roughly divides the deposits into two lobes.

The Mt. Peron niche is 700 m wide and 600 m high, S-to-SW facing partially circular scarp. Well visible on the wall are numerous faults and fractures belonging to five main discontinuity sets (shown in the stereograms of **Fig. 2**). These comprise: (1) bedding, (2) WSW-ENE directed frontal thrust planes, (3) NW vergent backthrusts, and (4) NNW-SSE aligned local conjugate fracture planes sets, (5) persistent N-S oriented Jurassic faults. Today myriad large and small individual rock prisms bound by these discontinuities are present at high elevation in the release area.

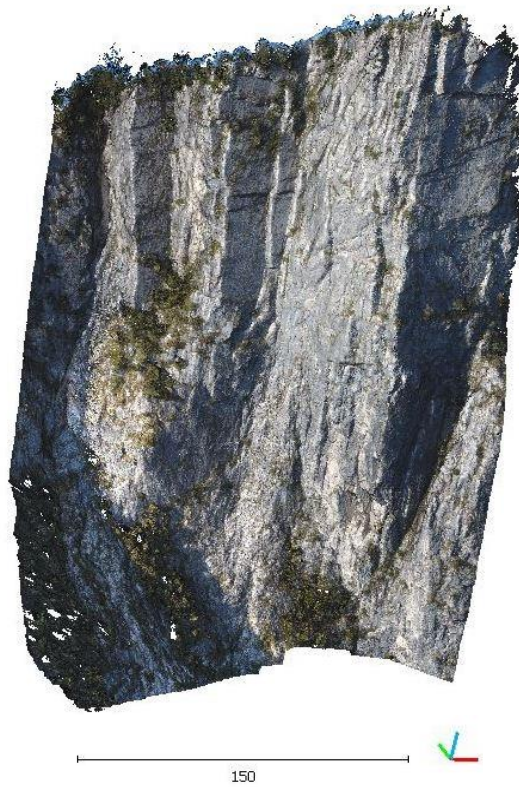
**Fig. 2:** Drone used during the surveys activities and points cloud generated using the acquired images.

For the 3-dimensional representation of the study area, a photogrammetric survey was performed taking 150 photos using a commercial drone/UAV (Unmanned Aerial Vehicle). From those images a points cloud (**Fig. 2**) and a triangular mesh have been built using the SfM (Structure from Motion) technique through the software Agisoft Photoscan<sup>©</sup>.

The point cloud allowed the measures of the planes of the bedding joints and fractures visible over the mountainside difficult to reach with a classic geomechanical survey. Totally, a number of 159 planes were taken. This approach can be considered as a “remote geomechanical survey” that is commonly performed nowadays thanks to drones features.
